The CMS pixel detector in LS1: a surprise with a happy end

Séminaires de physique corpusculaire
DPNC , 21. Sept 2015

R. Horisberger, PSI

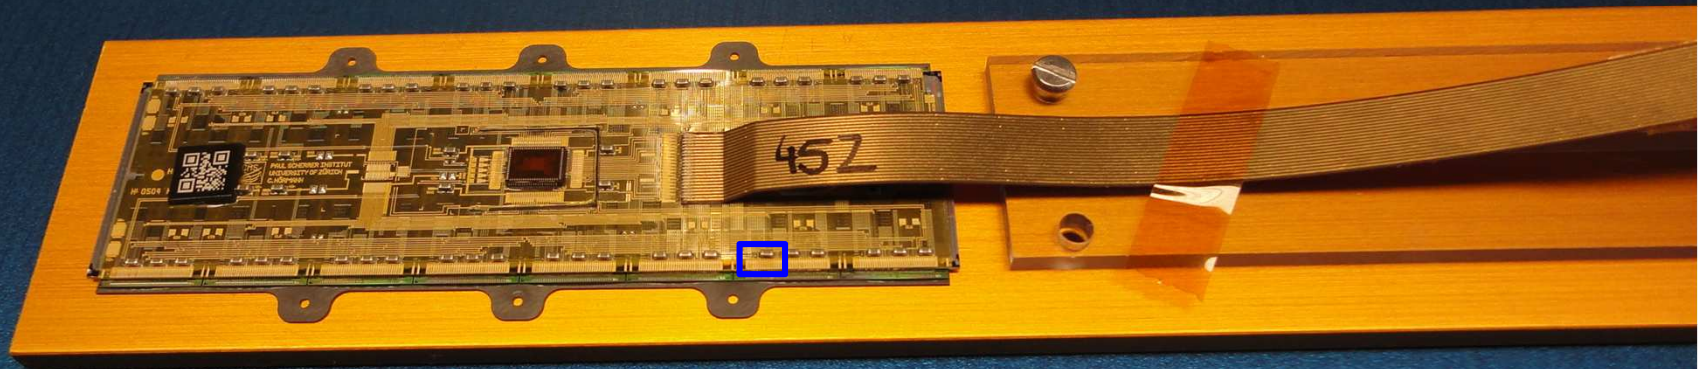
modules of low serial numbers almost always shorts at ROCs between **Reset-pin** & **Aout-pin**

serious damaged modules → multiple shorted modules e.g. also at **TBM-pads** & **cable pads** (very dirty too)

solder footprint
rosin based flux

observe typically shorts between pads with
2-2.5V adjacent voltage differences and
proximity to SMD components

→ observe shorts to disappear when
raising current above ~ 20mA

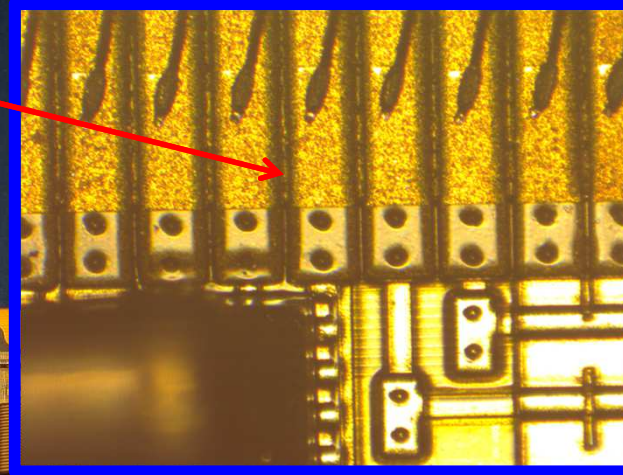
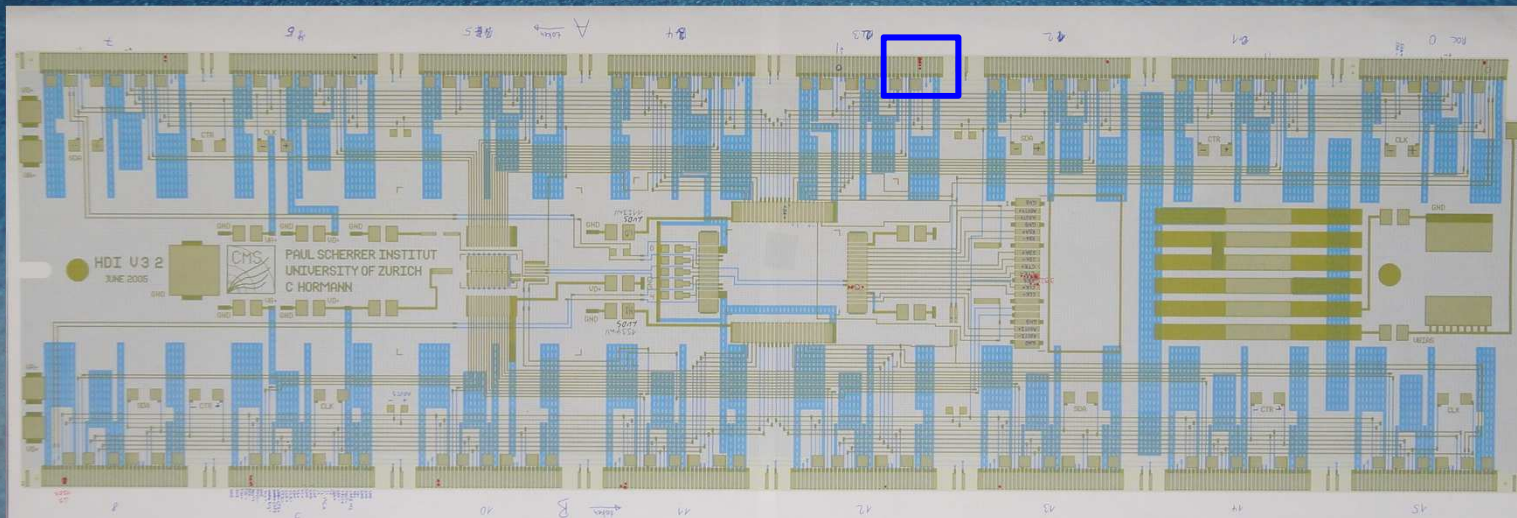
HDI shorts “always” happen at Reset / Aout

typical short
Reset - Aout

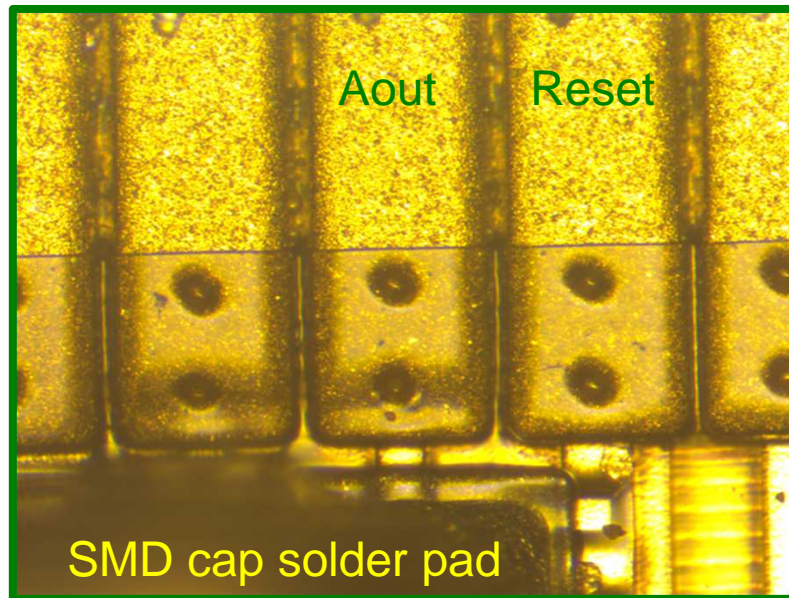
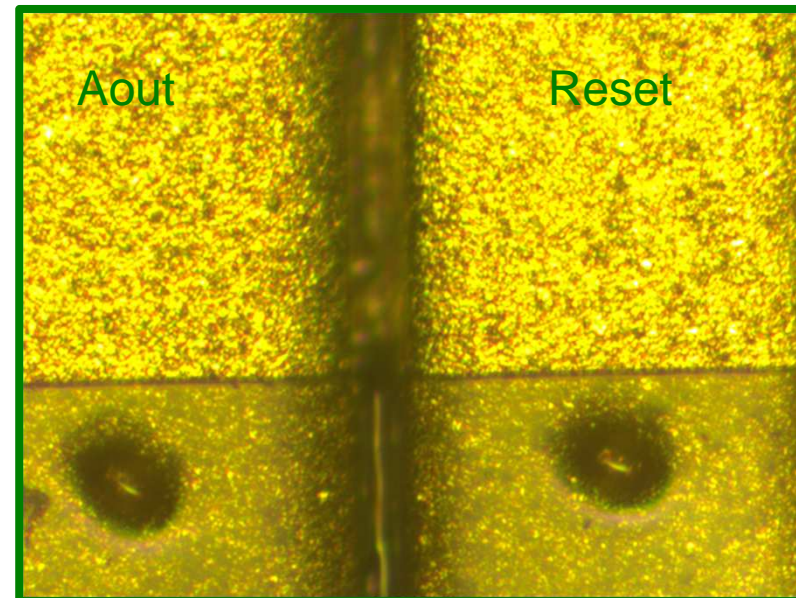
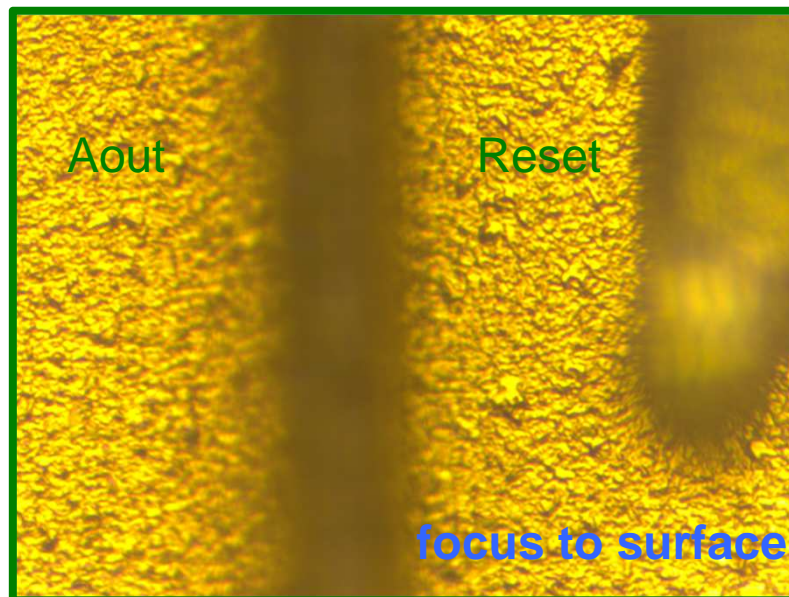
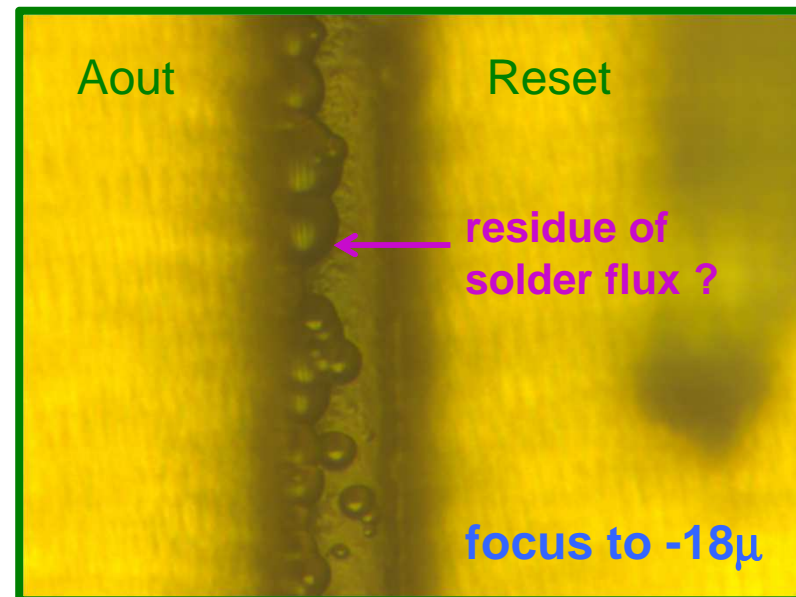
Zoom into cracks between pads

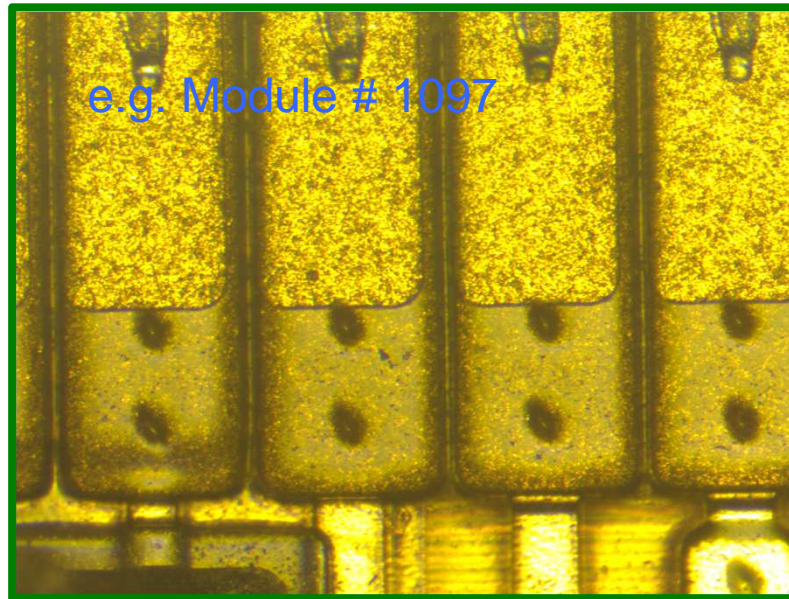
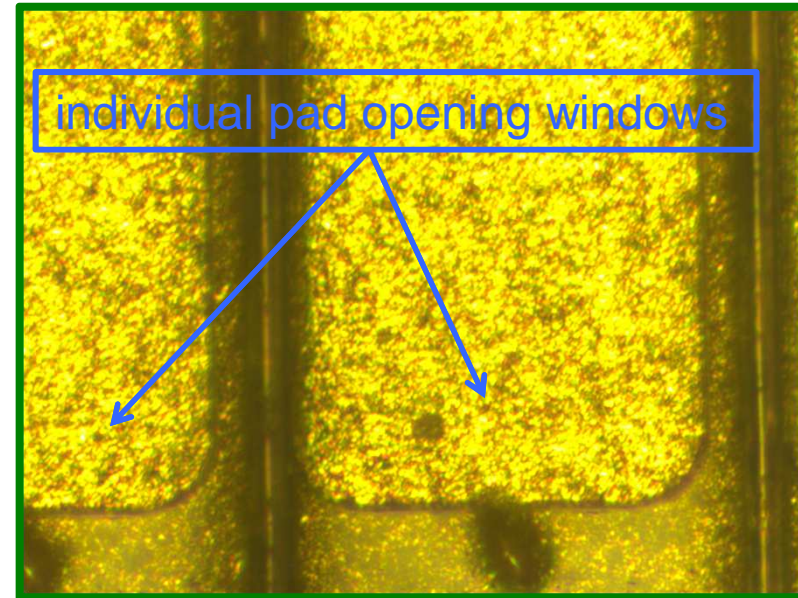
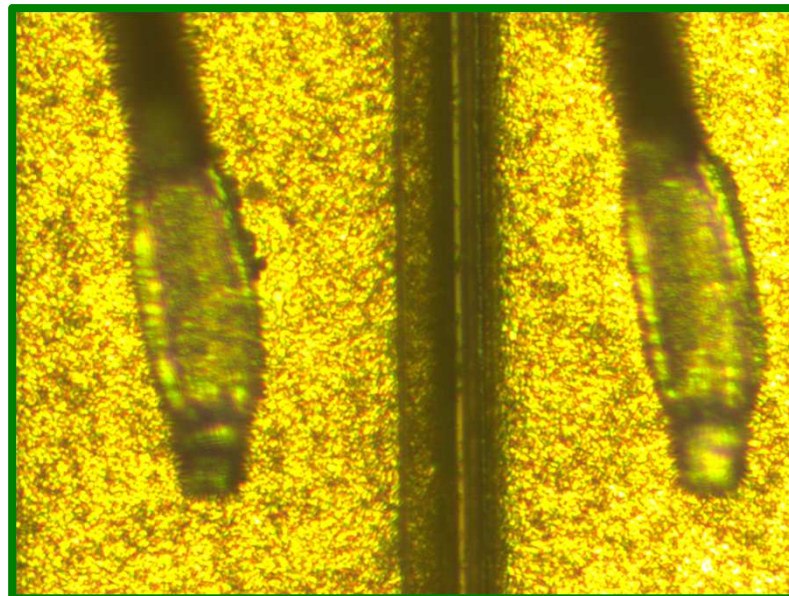
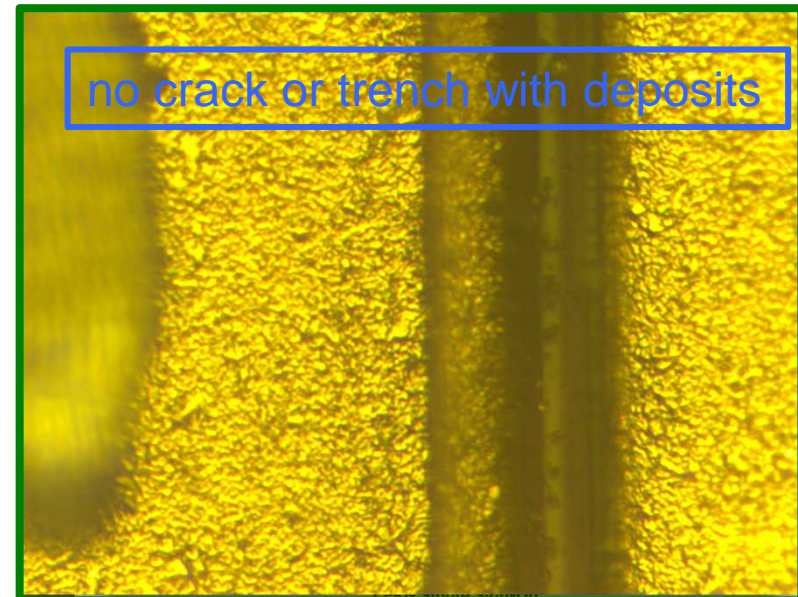
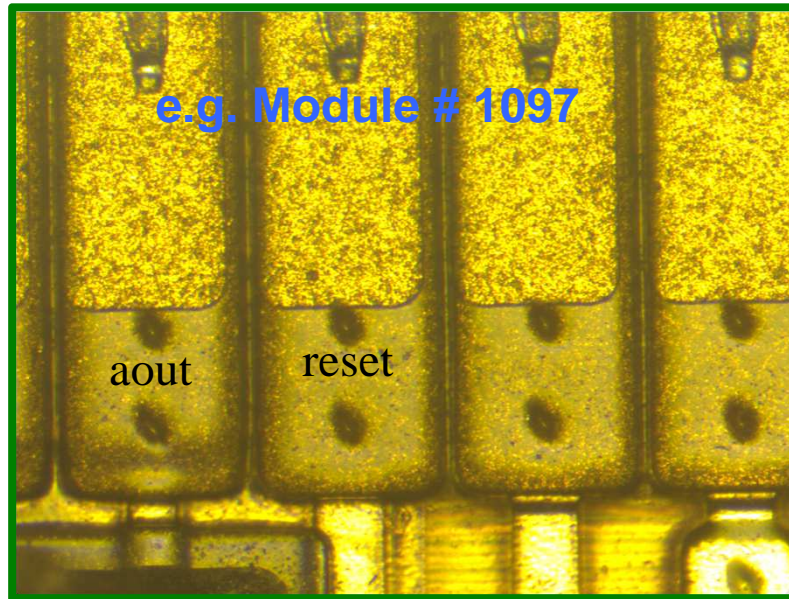
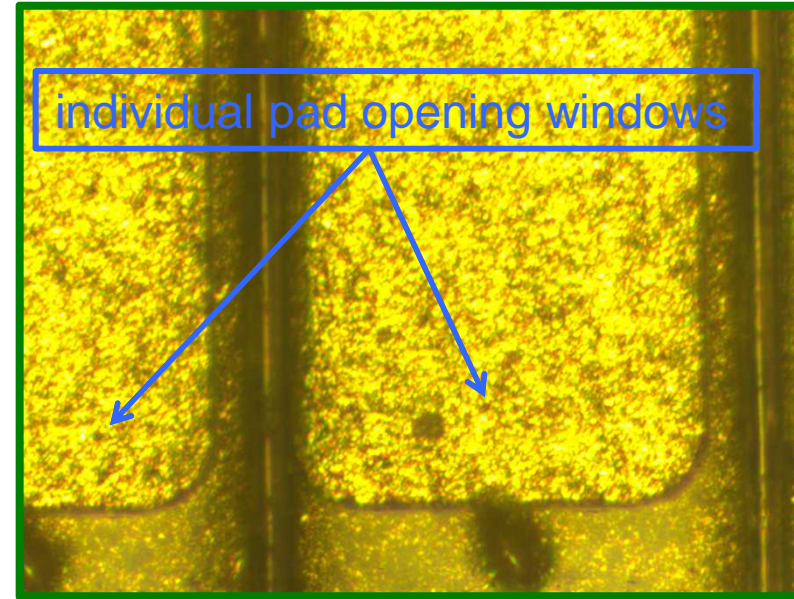
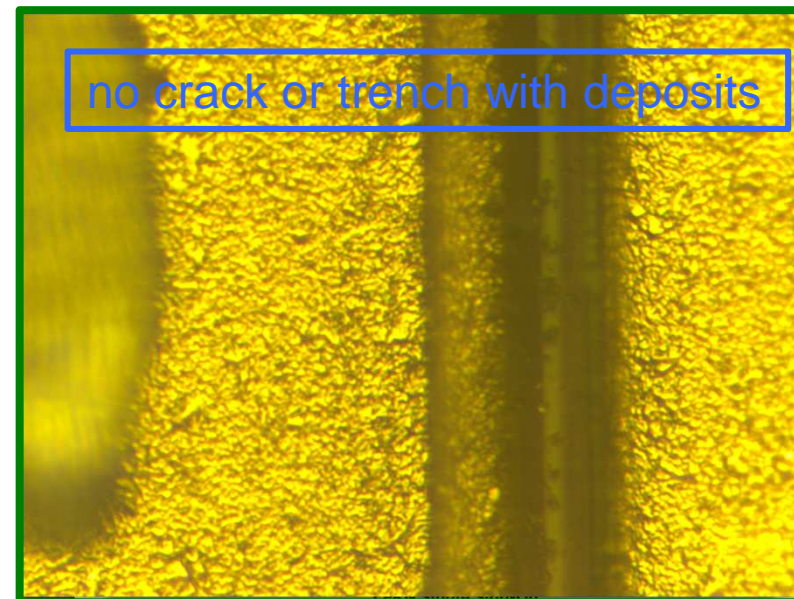
ROC pads of HDI from 2005-2006
→ used till module # ~ 700

ROC pads of HDI from 2006-2007
→ used in module # ~ 700- 1200

From all the ~50 defect modules (some with multiple shorts) have **not seen a single short** between pads with individual pad openings.

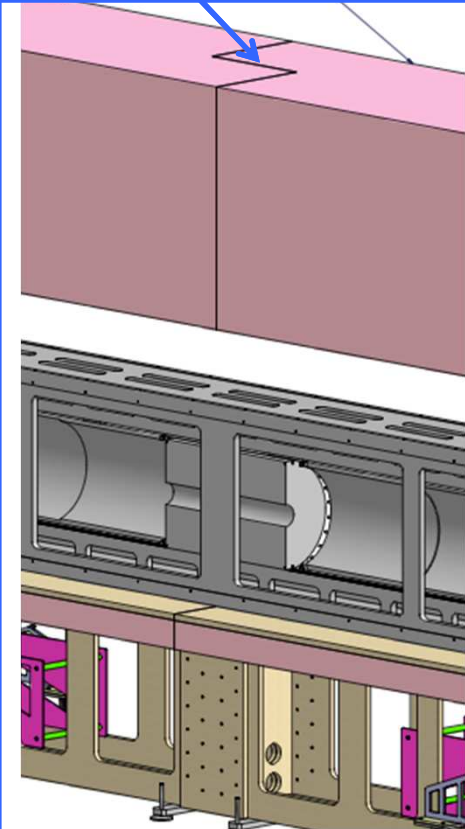
Most likely scenario of events:

- thermal covers opened / closed many times 2013/14
- sealing in Nov/Dec 2013 tests probably left small leak at $z \sim 0$
- small plumes of humid air (\sim liters/min) leak inside volume

- copper cooling plate at $\sim 0^\circ\text{C}$ with air temperature $\sim +8^\circ\text{C}$
- ventilators pull down air flow from gap of thermal covers

- local humidity cloud deposits micron thick ice film on **coldest surfaces** \rightarrow **pixel modules & cooling pipes** (-16°C)
- modules under power melt the ice, since HDI on top of sensor has poor thermal contact to cooling pipes.

- **sectors under test** with **power** gets **damaged** by electro-chemical migration with metalorganic-complexes from flux residues in very narrow, deep HDI cracks of early serial #'s.

humid air intake in unclosed gap
