Status of ladder and plane integration

D. Rapin, Univ GVA oct 06
Tracker splinter meeting

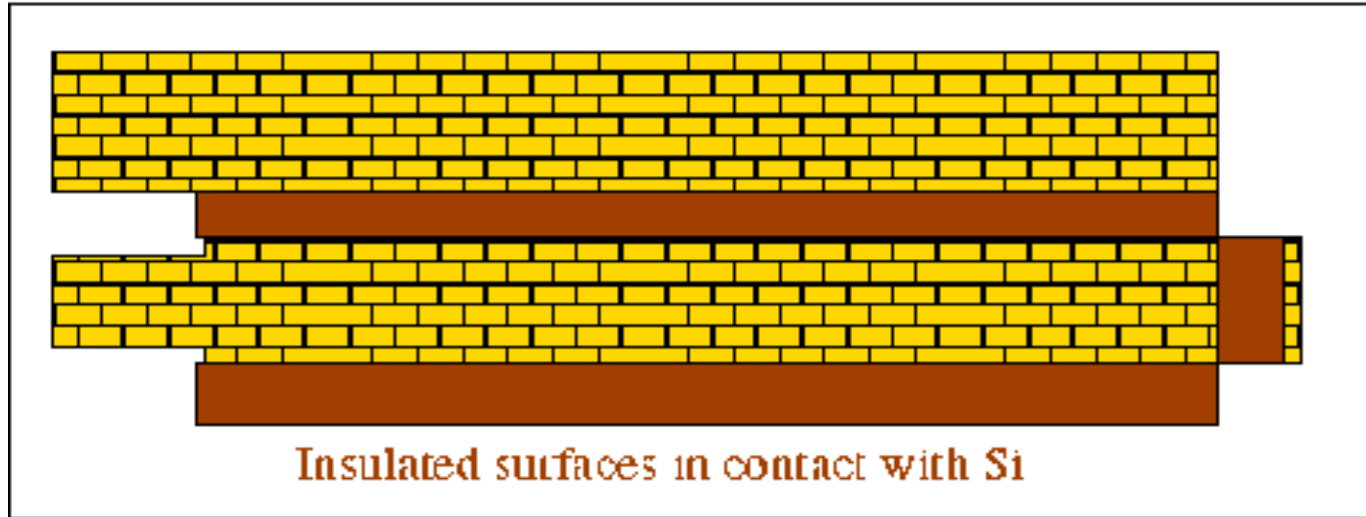
- Shorts circuits ($\sim 100\text{-}200\text{ }\mu\text{A}$) appeared after shielding for two series.
- Some conductivity was detected between upilex surfaces and metalization.
- Ok after cleaning. (Water, Alcool, Aceton)
- Direct contacts with CICOREL:
 - They recognized that some electrolyte can remain after cleaning.
 - They suggest to clean it with water only, if possible.
- Series: SN11N27-31 (sep03), SN15U03-13 (sep04)

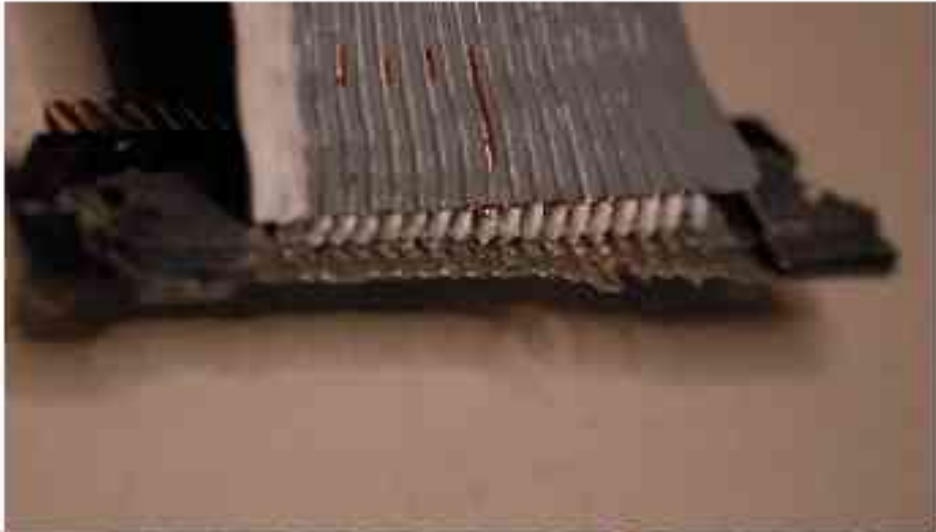
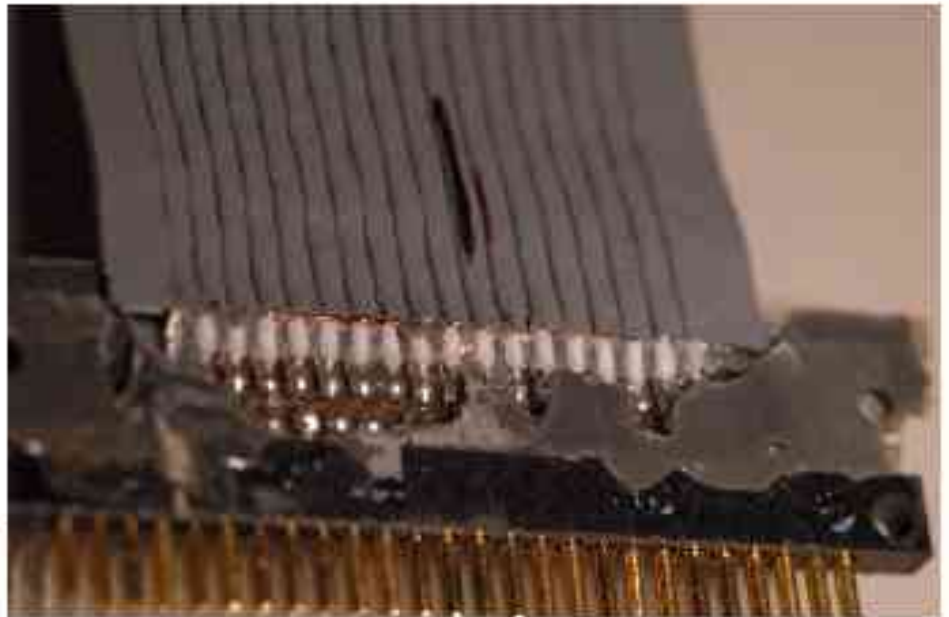
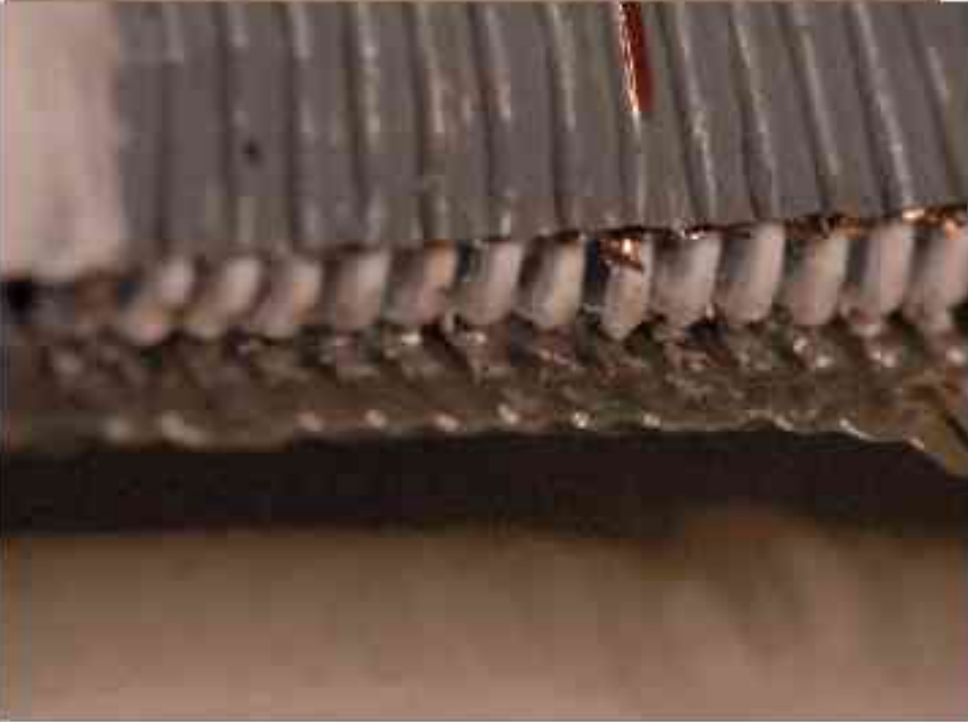
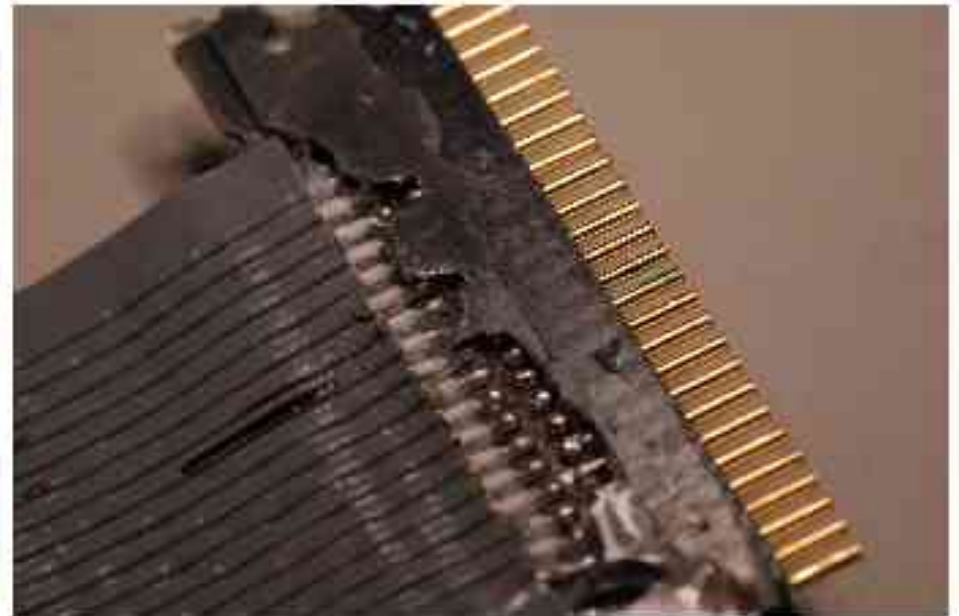
Example of intermittent short circuit with shield.

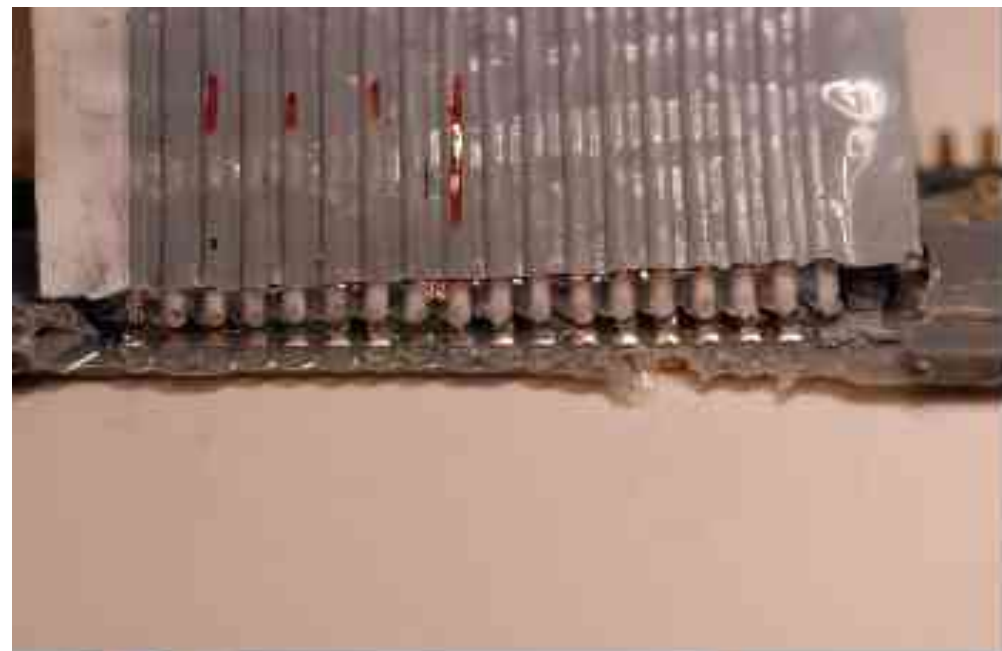
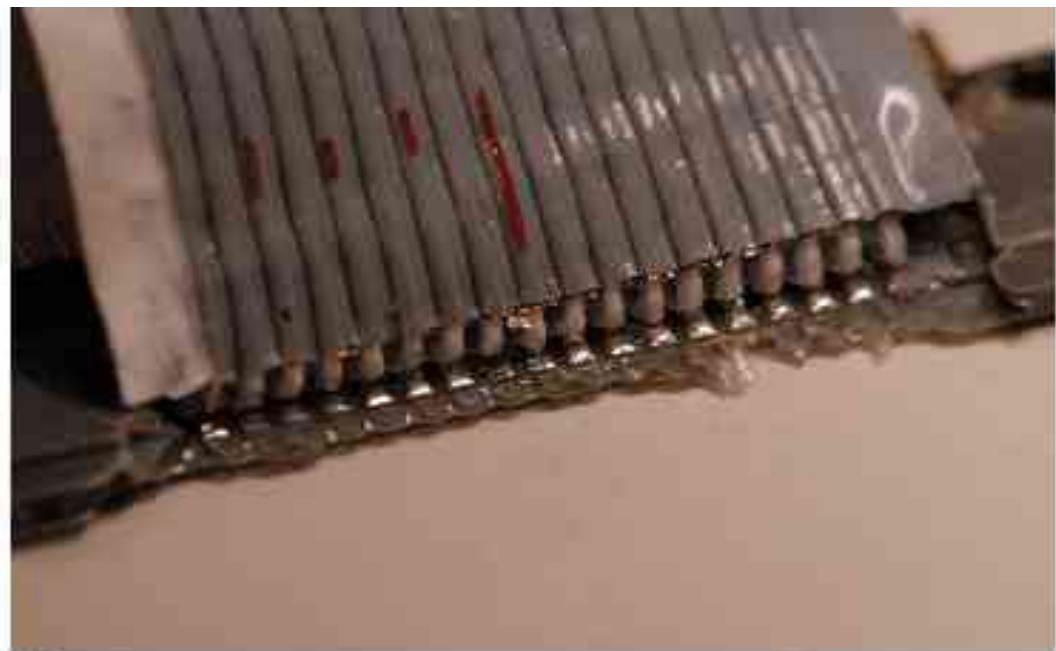
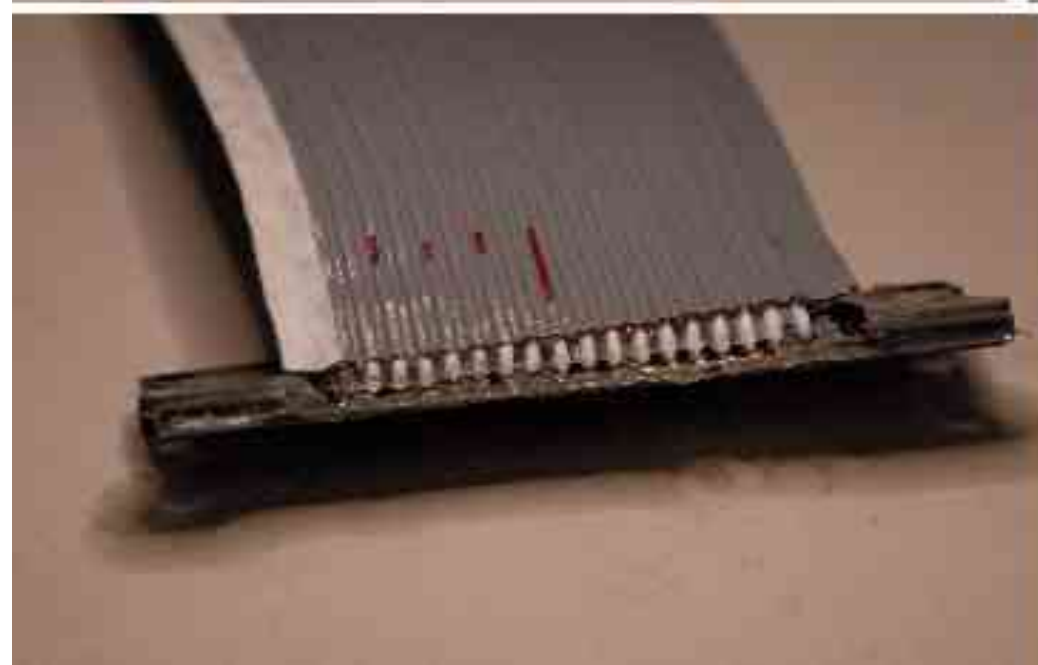
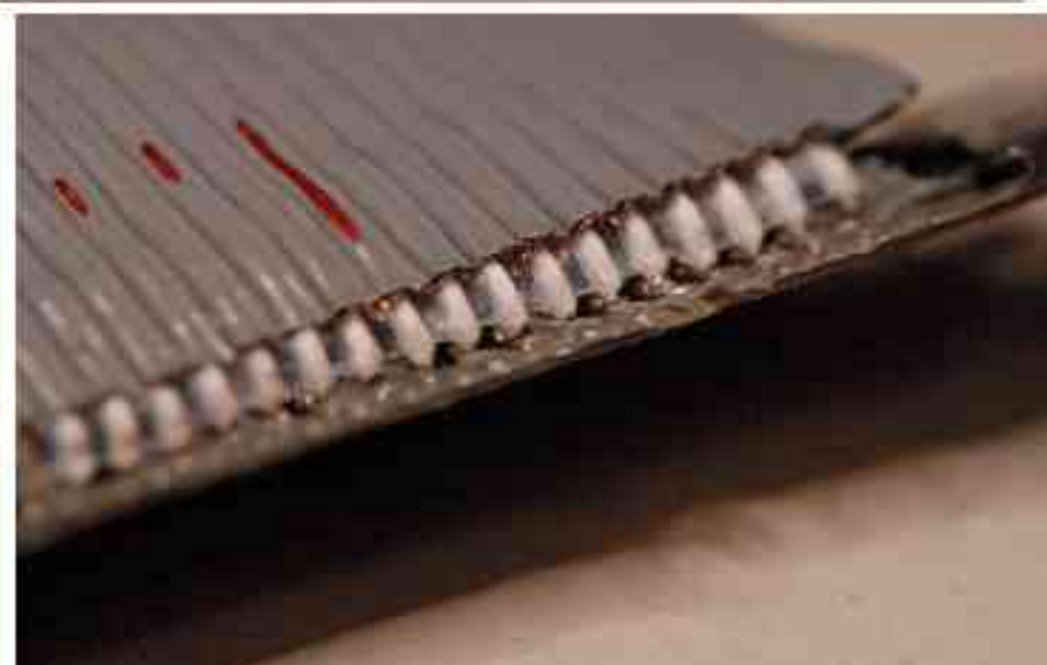
Example of intermittent short circuit with shield.
