## Module 1 assembled at UniGe

Module completion on 15 Dec 2009

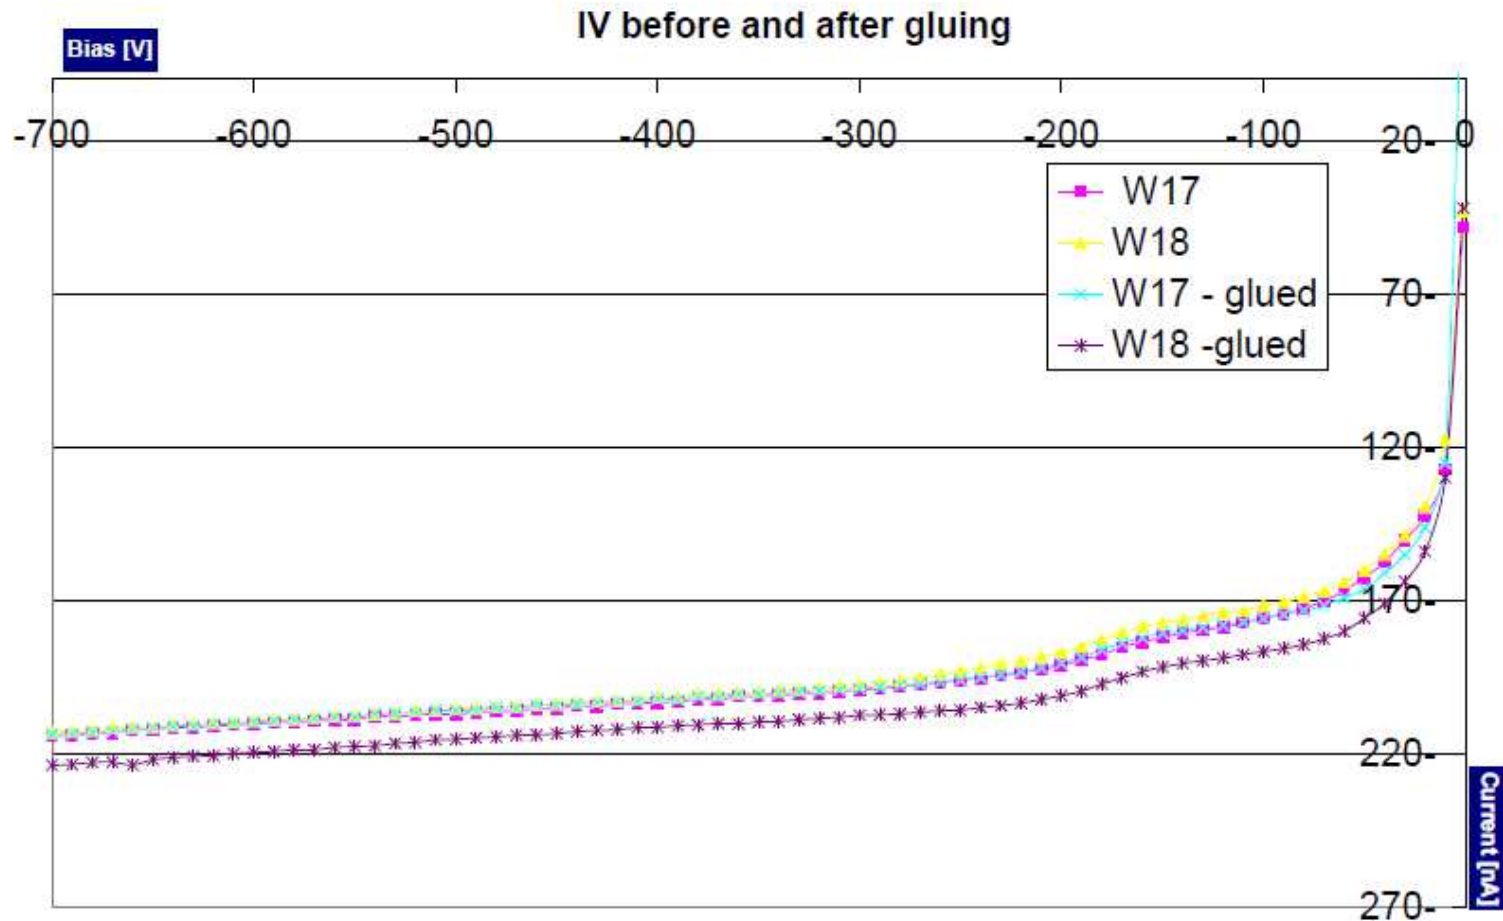
## Detector IVs

- *W18 start to leak around 750V.* This detector was already problematic before gluing!
- **Once hybrid glued discharge is observed around 300V** on W18 (We are not sure it is intrinsic to the detector)
- W17 (top side) is fine up to 1000V all along the assembly

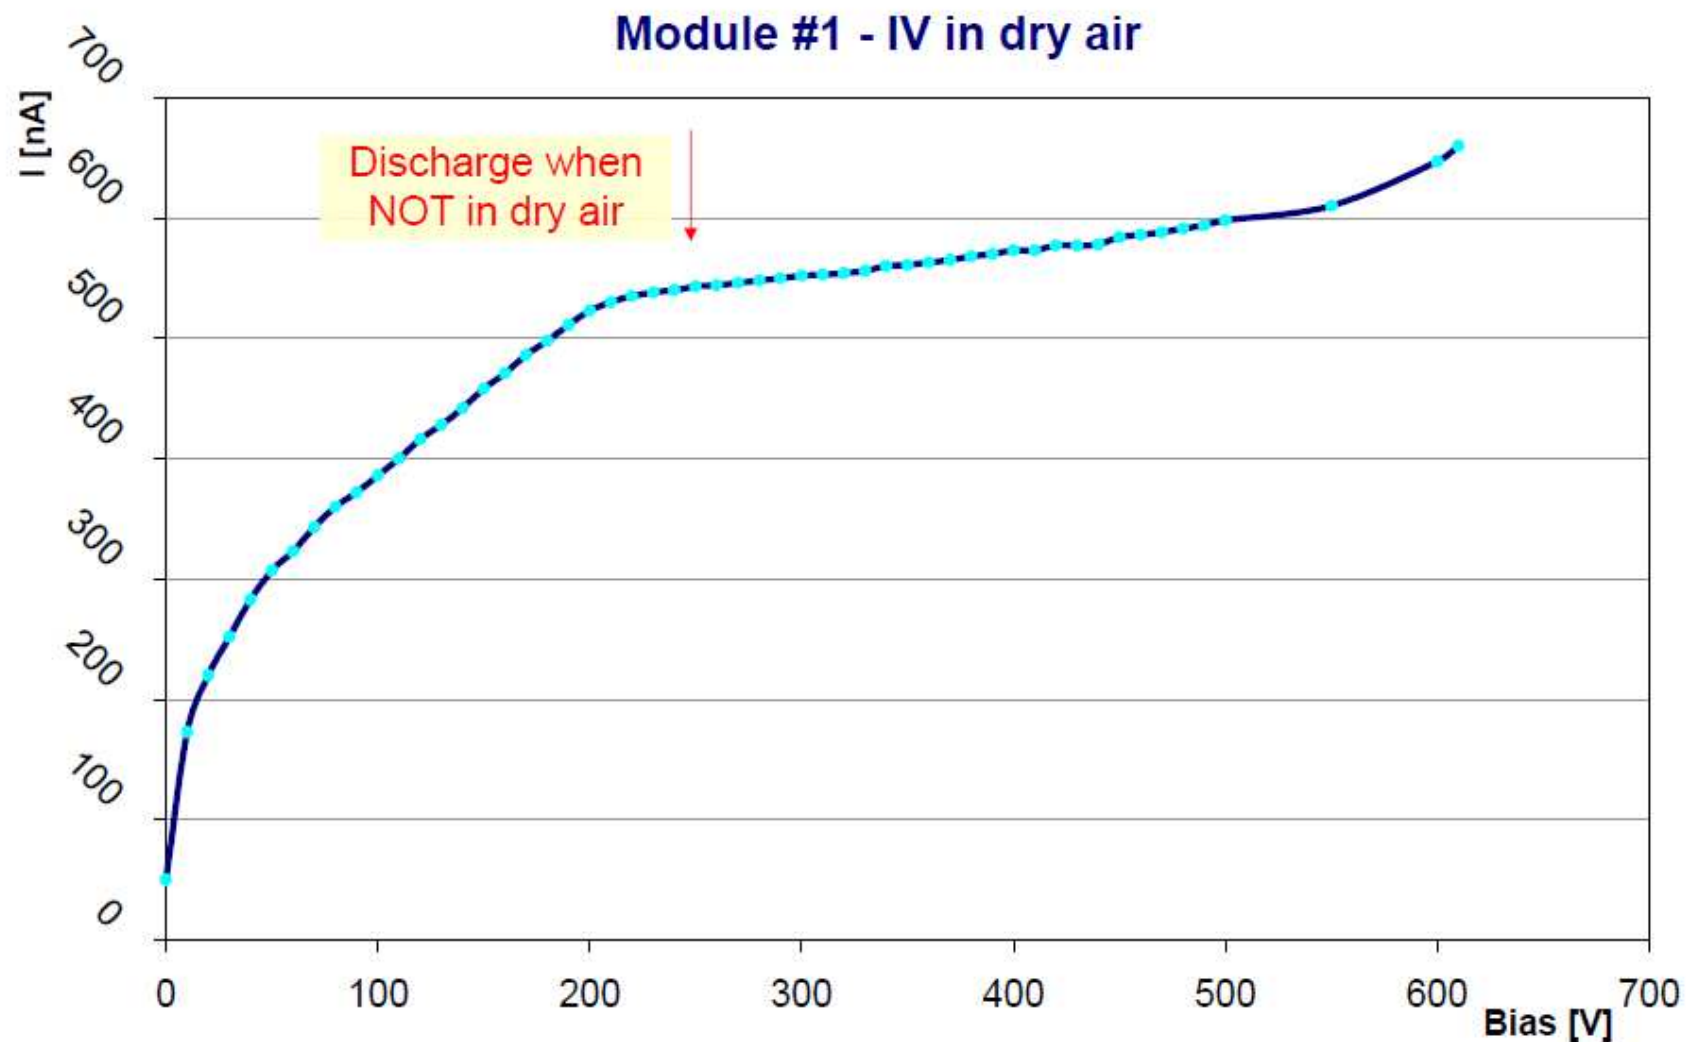
## Detector IV – Module 1 fully bonded

- Tested at CERN with K6517A on Dec 16th 2009 at room temperature and flushed with dry air
- When no dry air then discharges start to be seen around 250V
