Module 7

Report on the last investigation made

November 1, 2010

Module 7 status as of 29 October 2010

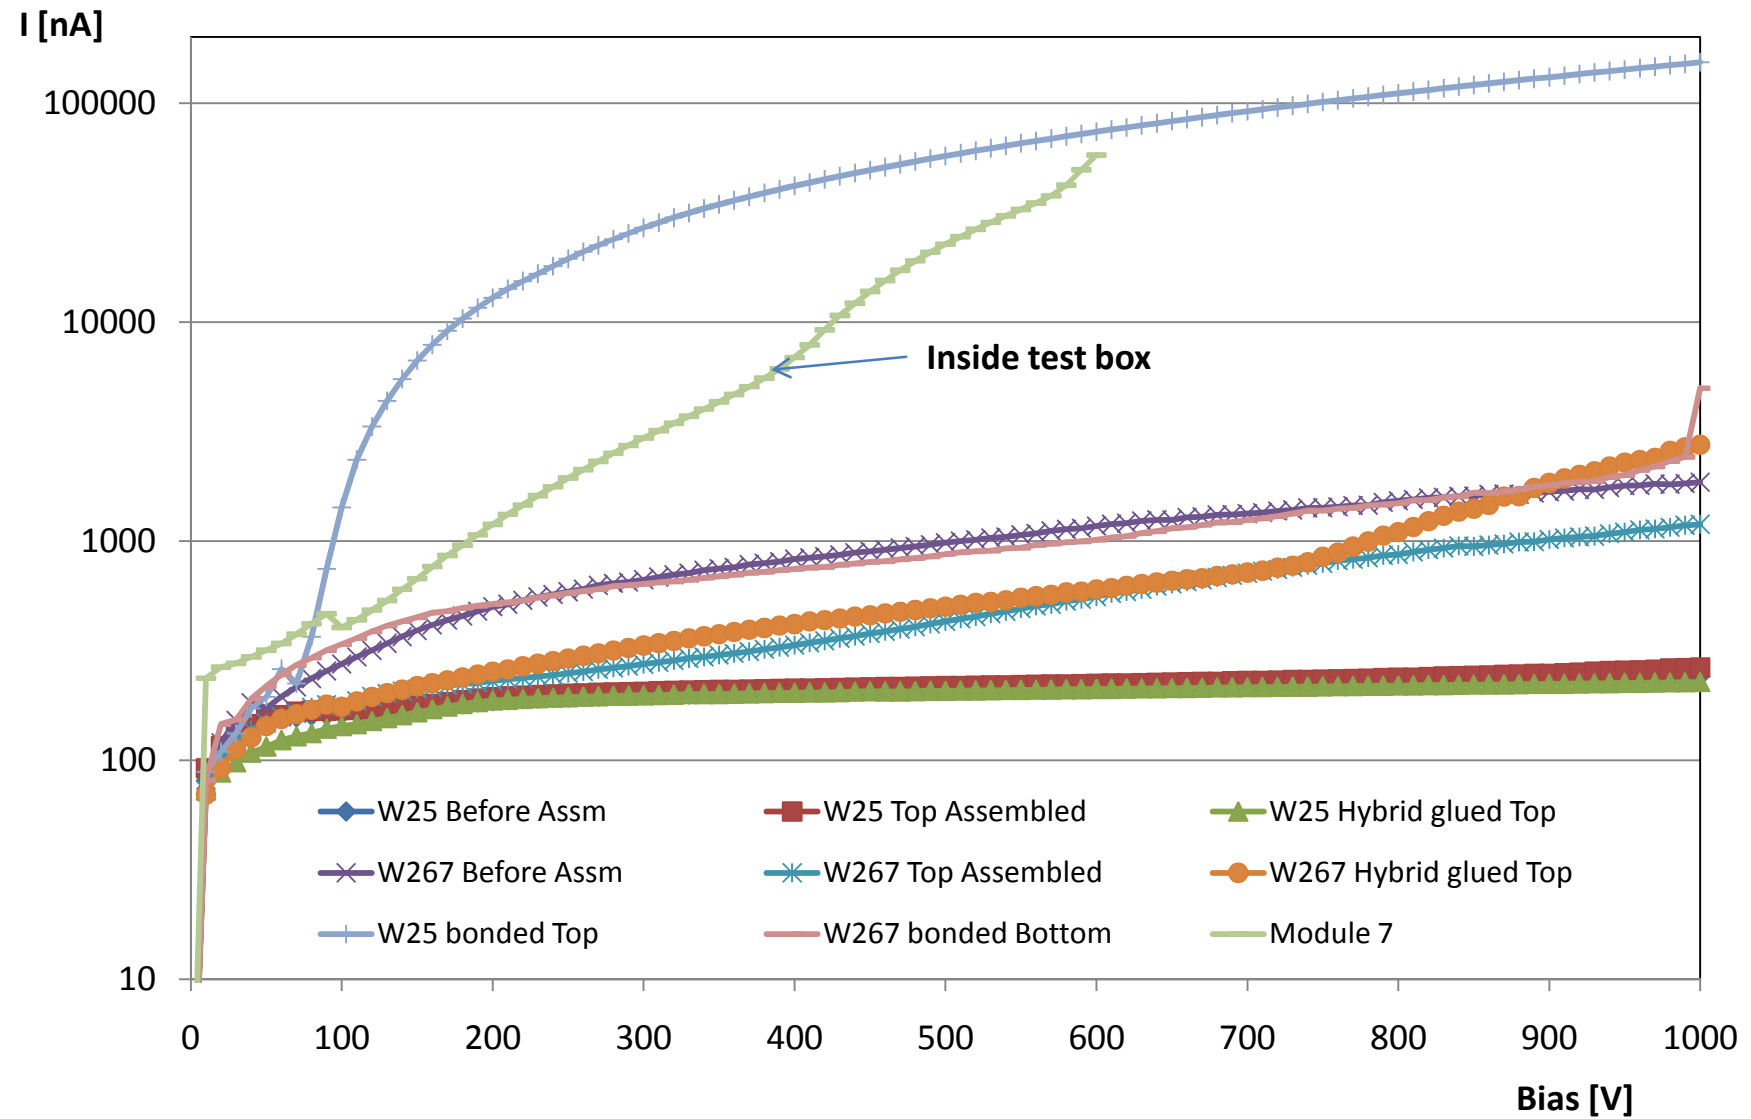
IV of Module 7 at various assembly/test steps

Step	Date	Comments
Assembly completion	13.10	IV was OK before bonding No IV made just right after bonding
1 st tests at CERN	14.10	IV trip on ISEG around 250V – Dry air ON Identified that it was due to top side
Module back at UNI	15.10	Module mounted on Storage/bonding jig for investigation. Nothing seen! IV done with Keithley by probing side by side and 150A at 1000V. Module mounted back into test box and tested in IV with Keithley but got destroyed. With another Keithley I still could ramp-up the module but did not exceed 400V!
Module back at CERN 1 st readout at CERN	18.10	IV tripped at 250V → test done at 200V 1 st results presented by Sergio where top side was noisier . All hybrids could be readout
Module back at Uni for investigation	19.10	R11 (1 k Ω) resistors were found broken on all 4 hybrids. Bypass all the 4 resistors. Tested with Keithley and OK but did not go higher than 500V
Module back at CERN	20.10	Still problem with ISEG since HV tripped were seen

Step	Date	Comments
SMD HV replacement	26.10	All resistors and capacitors are now replaced. IV done with Keithley up to 600V after 2h stabilization at 500V.
Module back at CERN for test	27.10	Still HV trips seen ~ 200V with the ISEG. A Keithley has been transported at CERN such that characterization can be done at more than 200V!
CERN investigation	28.10	Tried to do readout tests but observed that as soon as the Chips are biased 10 microA more is seen on the HV line: 4 μ A when chips OFF and 14 μ A when chips are ON → 20 M Ω resistor more is added. Hybrid 0 could not be configured properly: Pipeline test shows problem on col0 and col1. Other 3 hybrids are OK.
Readout tests	29.10	Readout test of the 3 hybrids: H1, H2 and H3. All are OK and noise is ~ or below 600 e- as expected Nobu inspected in detail and under the microscope the module, sensors, chips, the SMD components, the Samtec connectors and could not find anything wrong. Nobu and Didier investigated the current problem via the HV and the chip power supply. It is connected to the 2.5V on hybrid and not even to the ground.

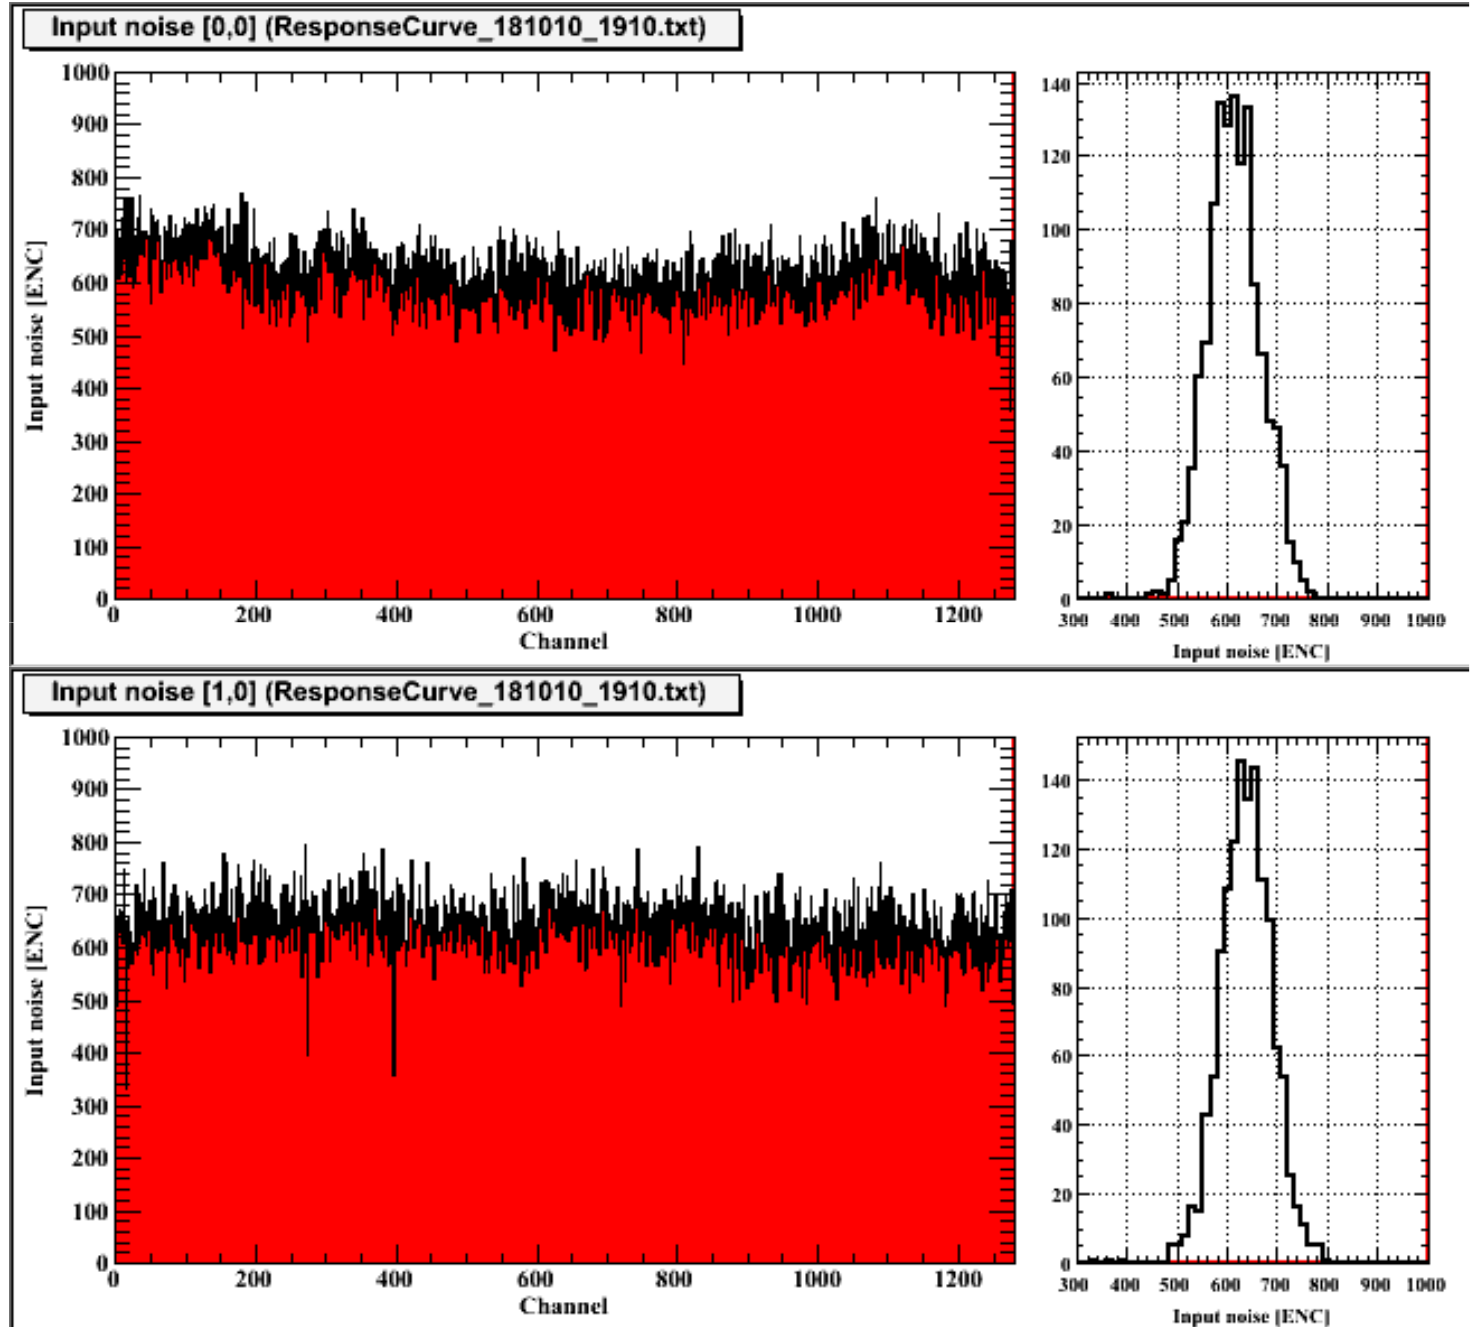
Noise – Test made on October 18th - Con't

200V bias on ISEG

it is suspected that due to
broken resistors the
effective bias was ~100V

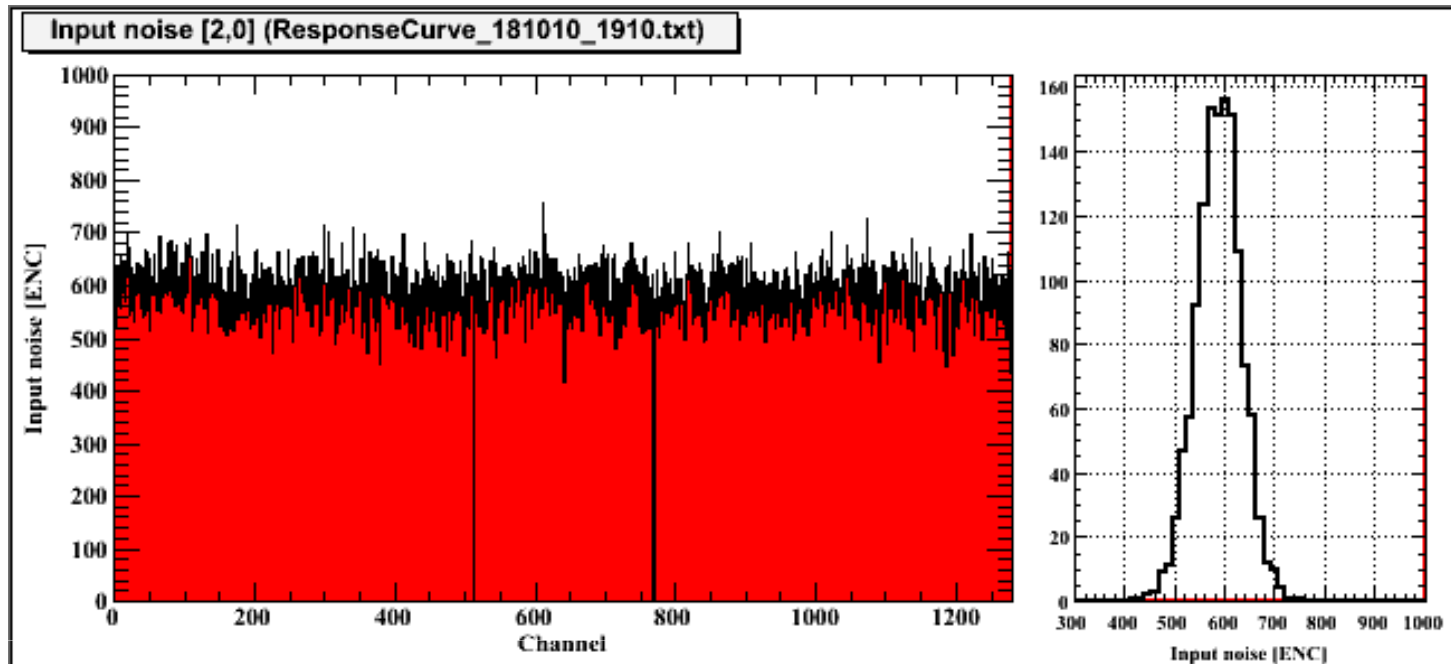
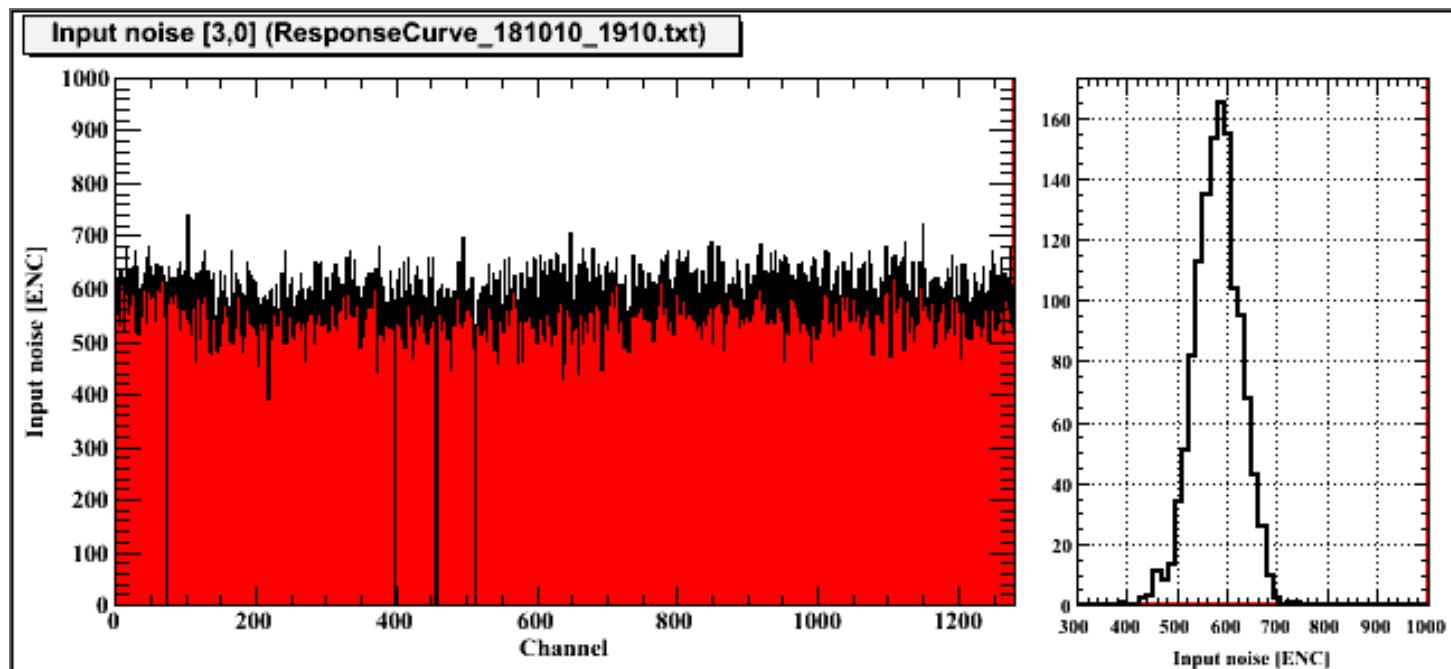
Noise – Test made on October 18th

200V bias

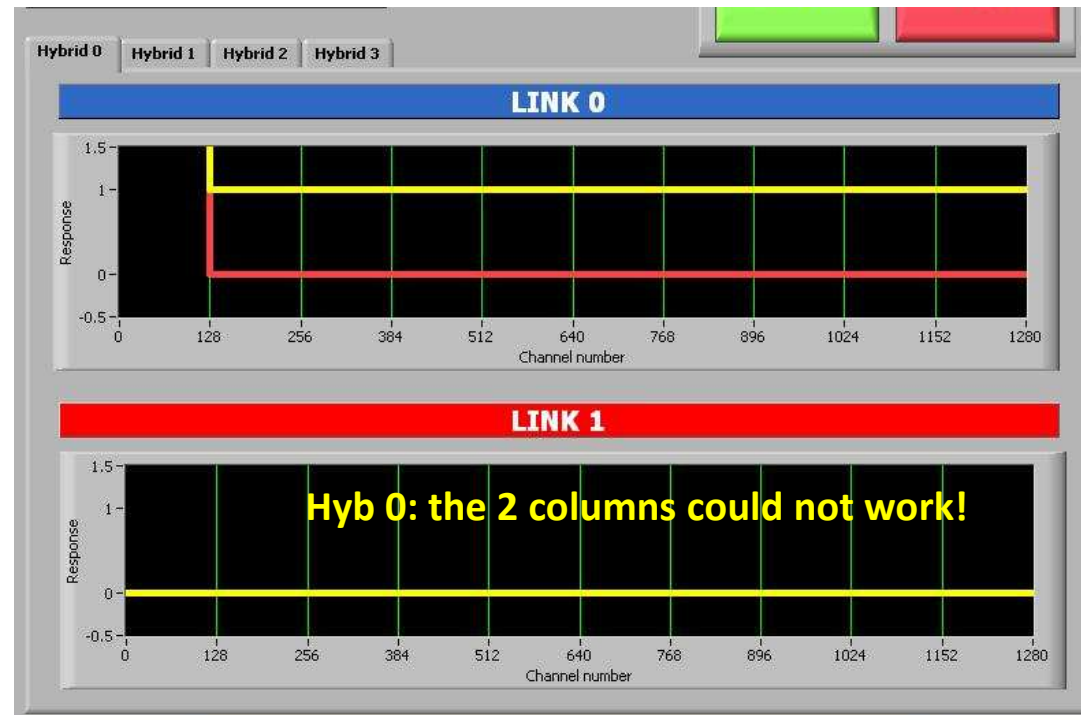
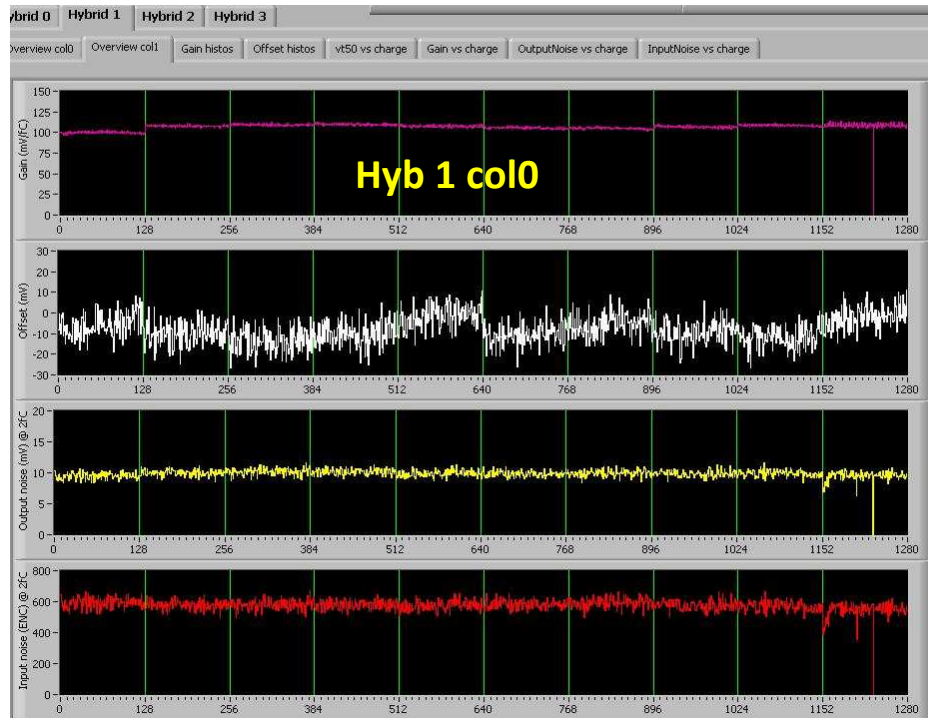
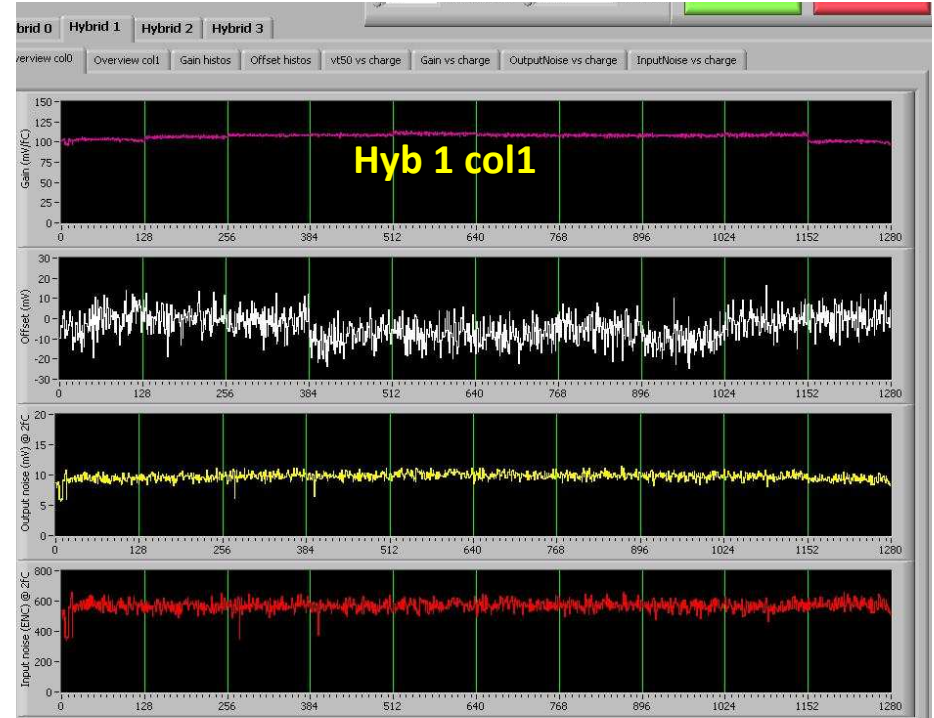
Noise – Test made on October 29th

Top side
