The CMS pixel detector in LS1: a surprise with a happy end

Séminaires de physique corpusculaire
DPNC , 21. Sept 2015

R. Horisberger, PSI

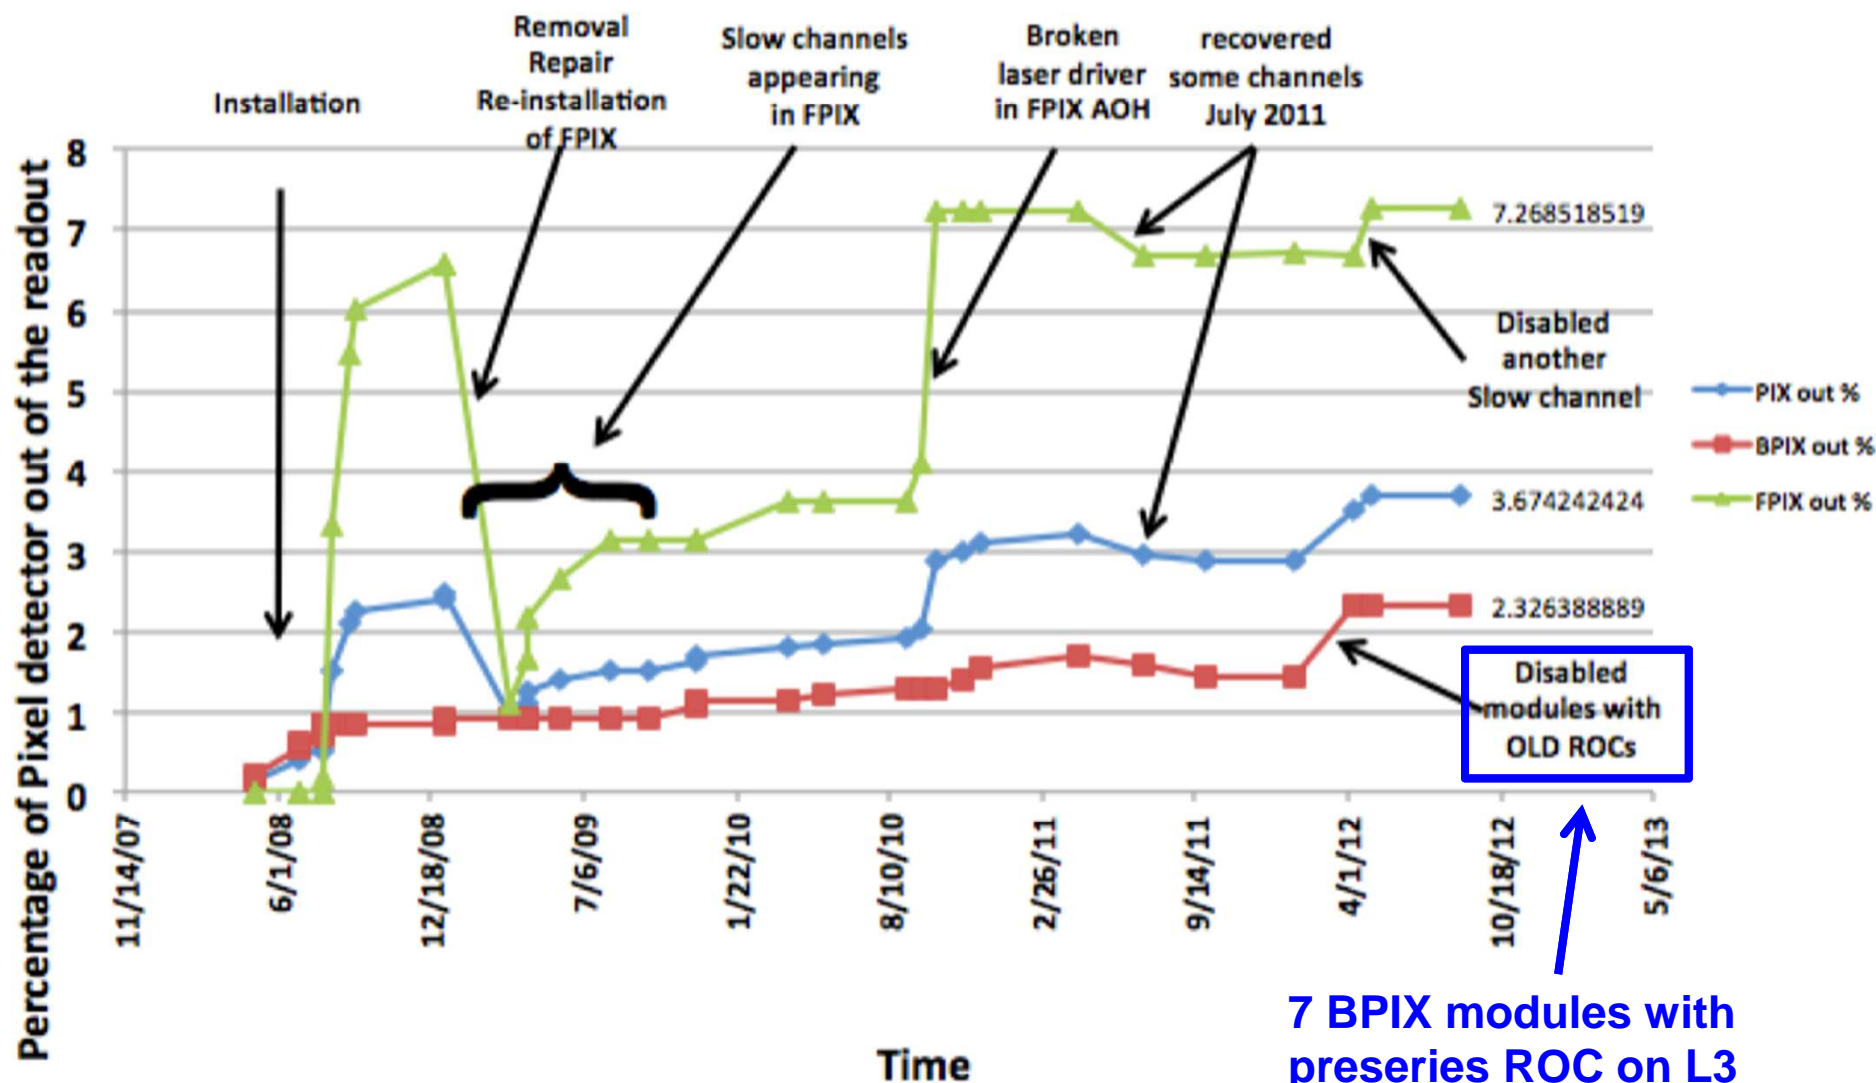
7 BPIX modules with preseries ROC on L3 disabled, replace in LS1

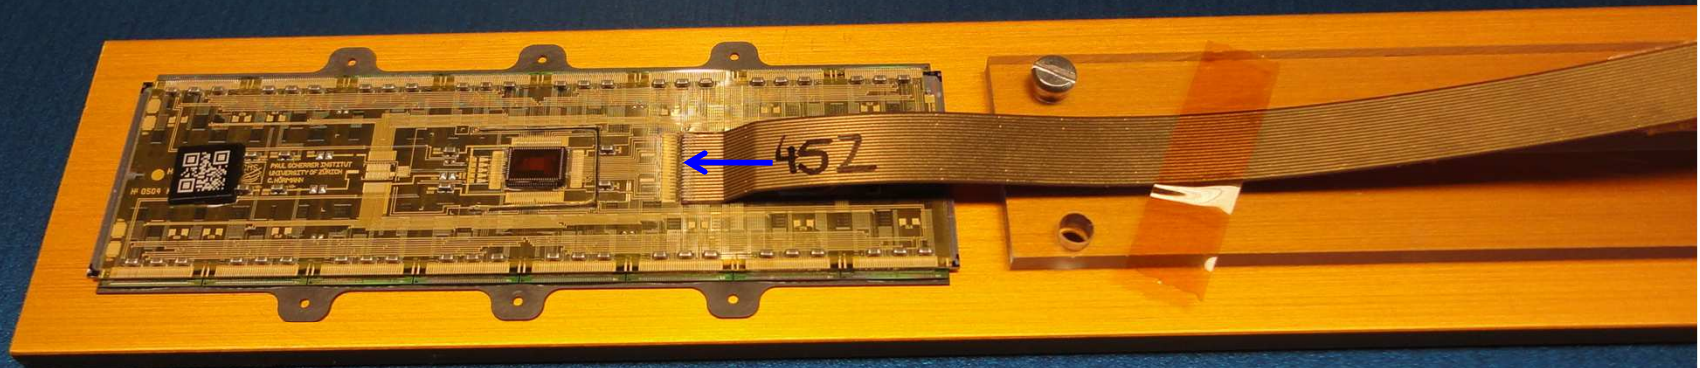
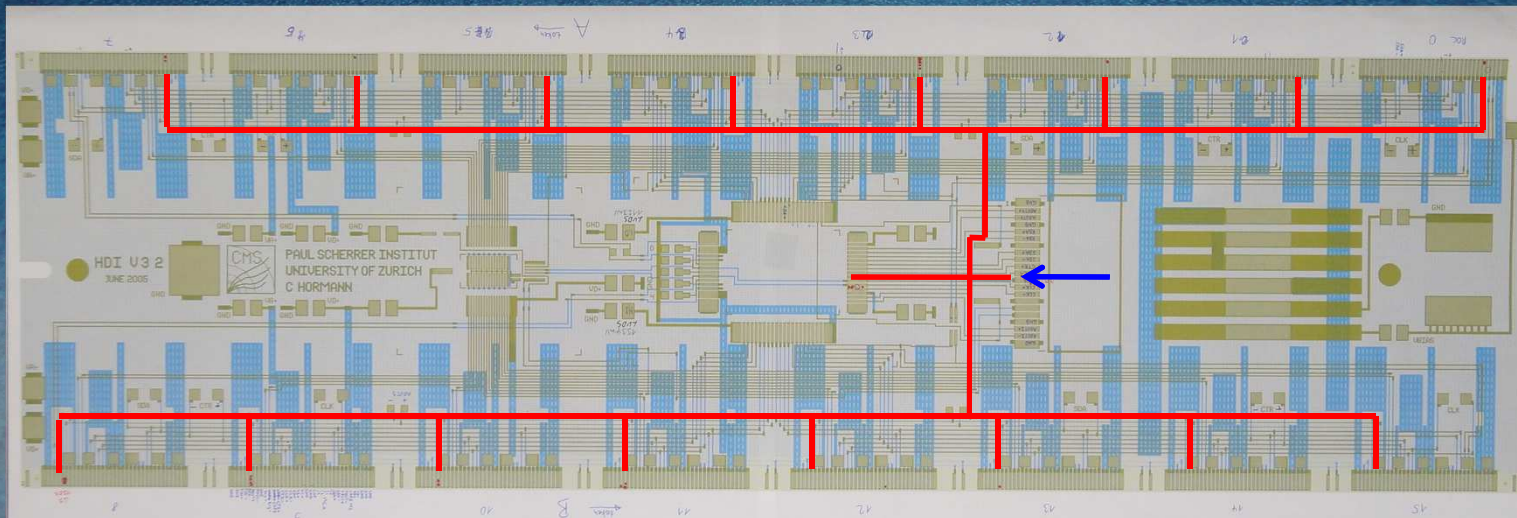
Module #69: (Layer 1, Ladder 7, Position +2) Hub ID=30

Reset line pulled down by $\sim 5\text{mA}$ by short to ground \rightarrow module reset

resistive path of reset line $\sim 2\Omega$ \rightarrow locate shorts by precise voltage measurement

Symptom: Reset line pulled down by ~5mA current to A_{out} pad

→ Precise measurement of voltage drop on Reset line shows **short at ROC 9**

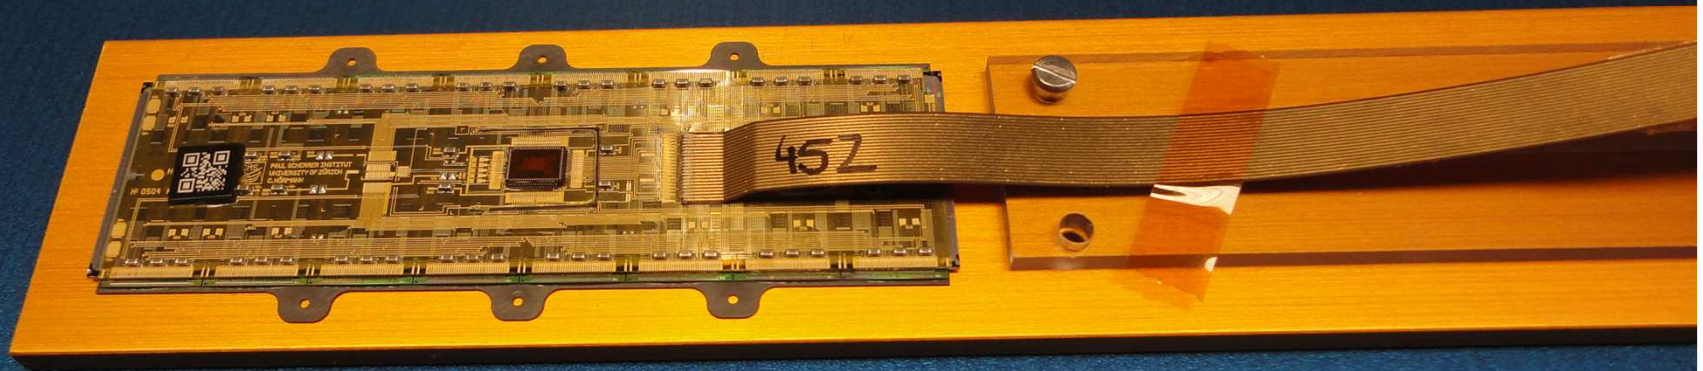
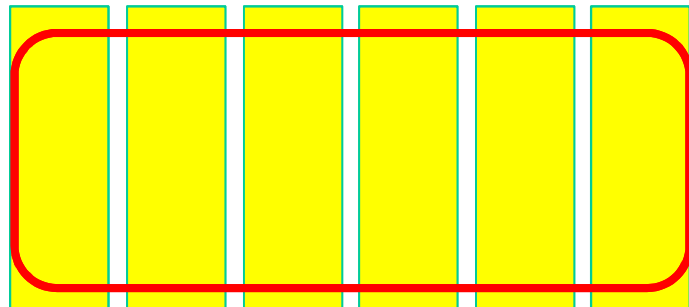
common pad passivation window

Passivation openings (windows) for ROC, TBM and Cable-pads

- TBM & Cable-pads with common windows for all HDI produced Dec. 2005 – Aug. 2007
- ROC pads with individual passivation windows for HDI produced Dec. 2006 – Aug. 2007

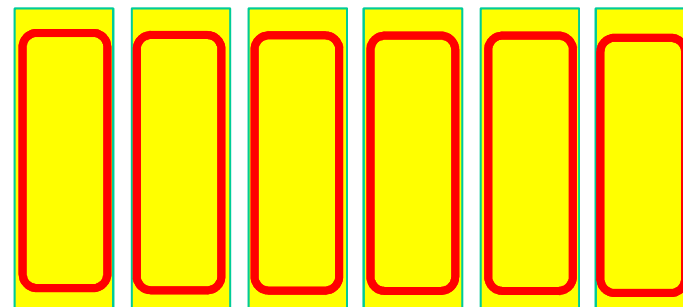
individual pad passivation window

From all the ~50 defect modules (some with multiple shorts) have **not seen a single short** between pads with individual pad openings.

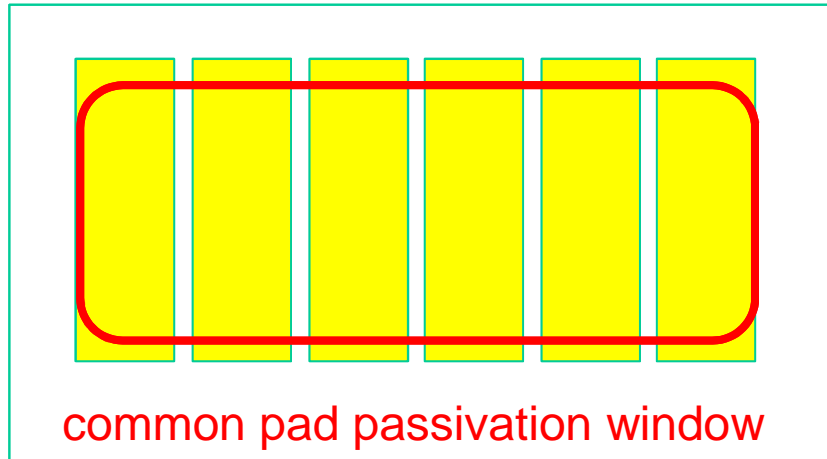
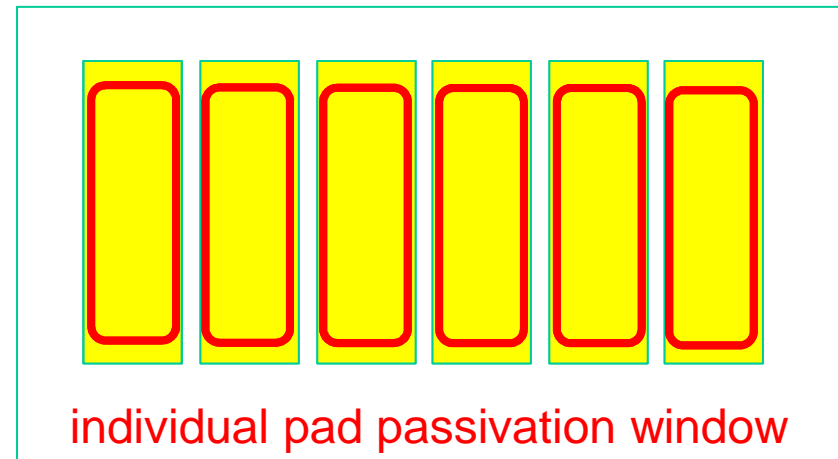
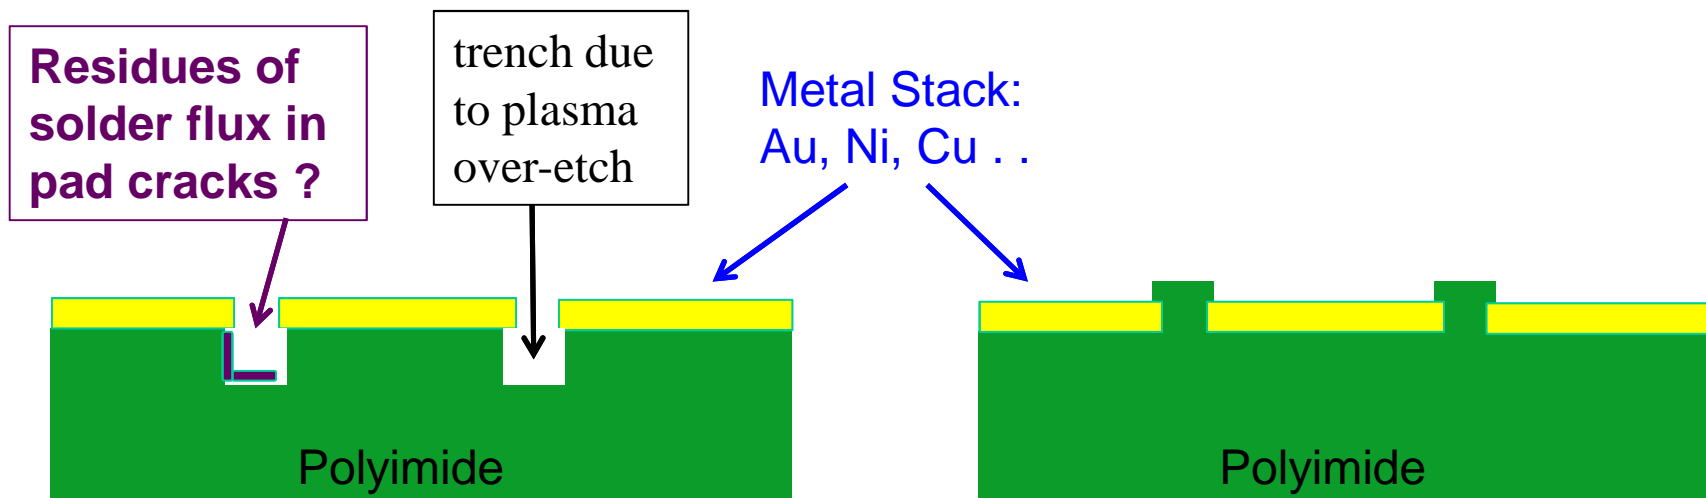
ROC pads of HDI from 2005-2006
→ used till module # ~ 700

ROC pads of HDI from 2006-2007
→ used in module # ~ 700- 1200

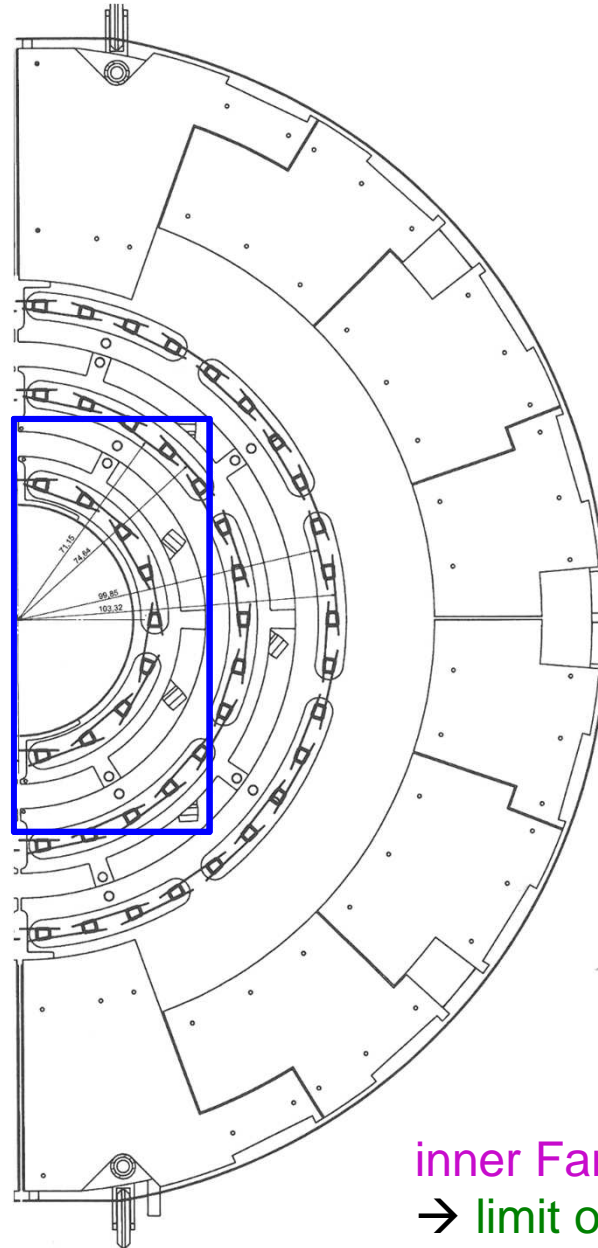
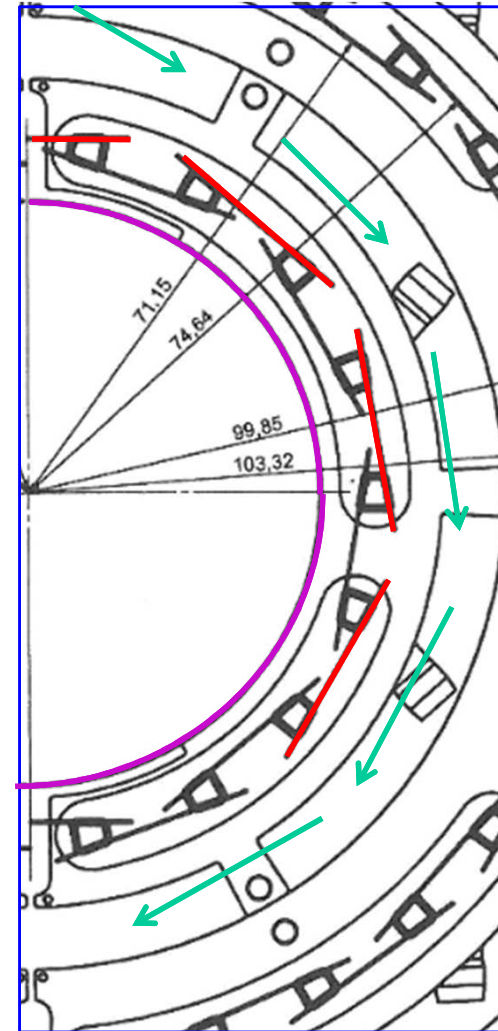
A striking pattern of damaged modules on the same mechanical half-shell !

ventilators underneath create vertically airflow down

inner Faraday shield very close to 1st Layer modules
→ limit of airflow for innermost oriented modules?

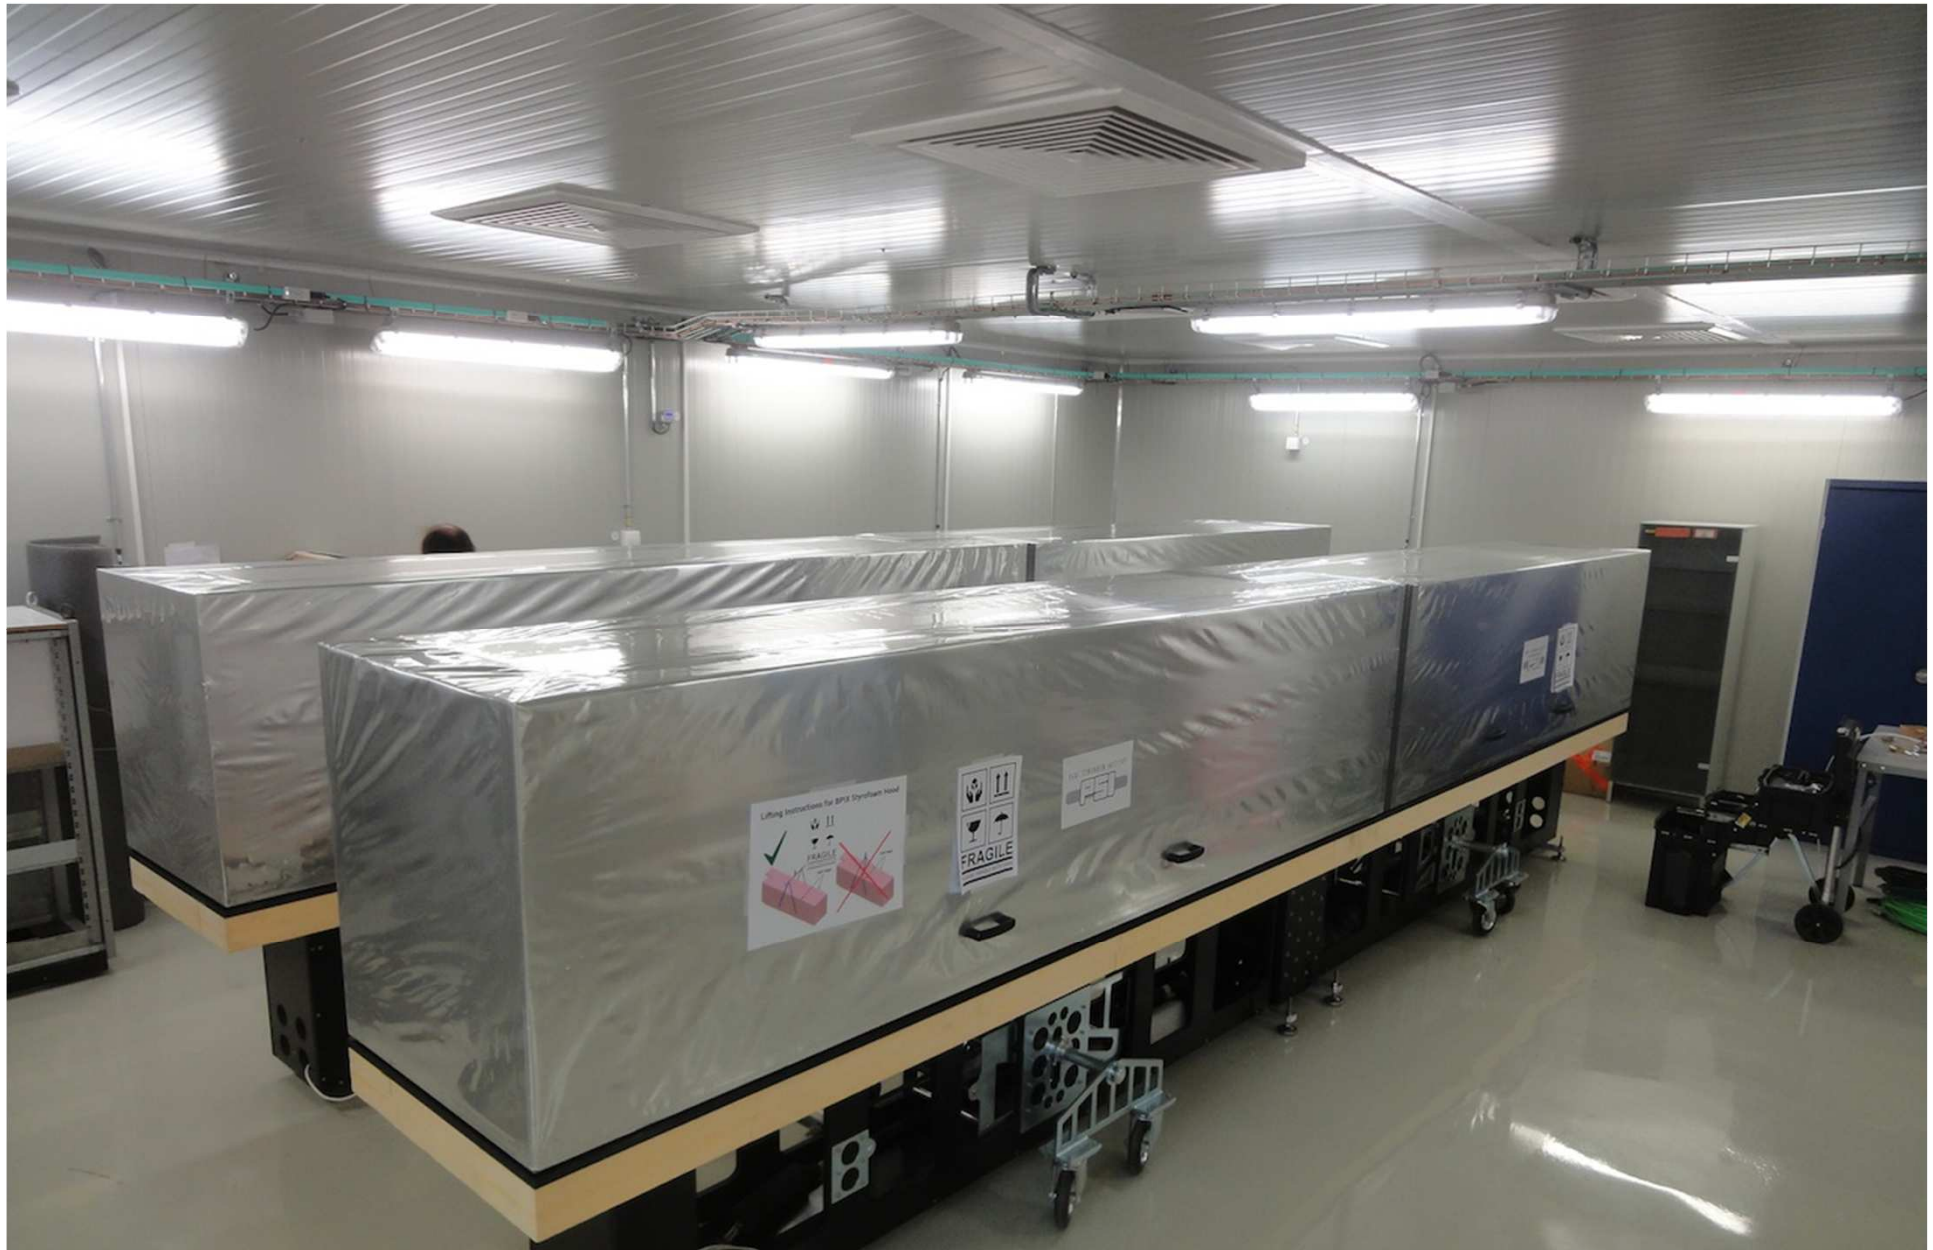
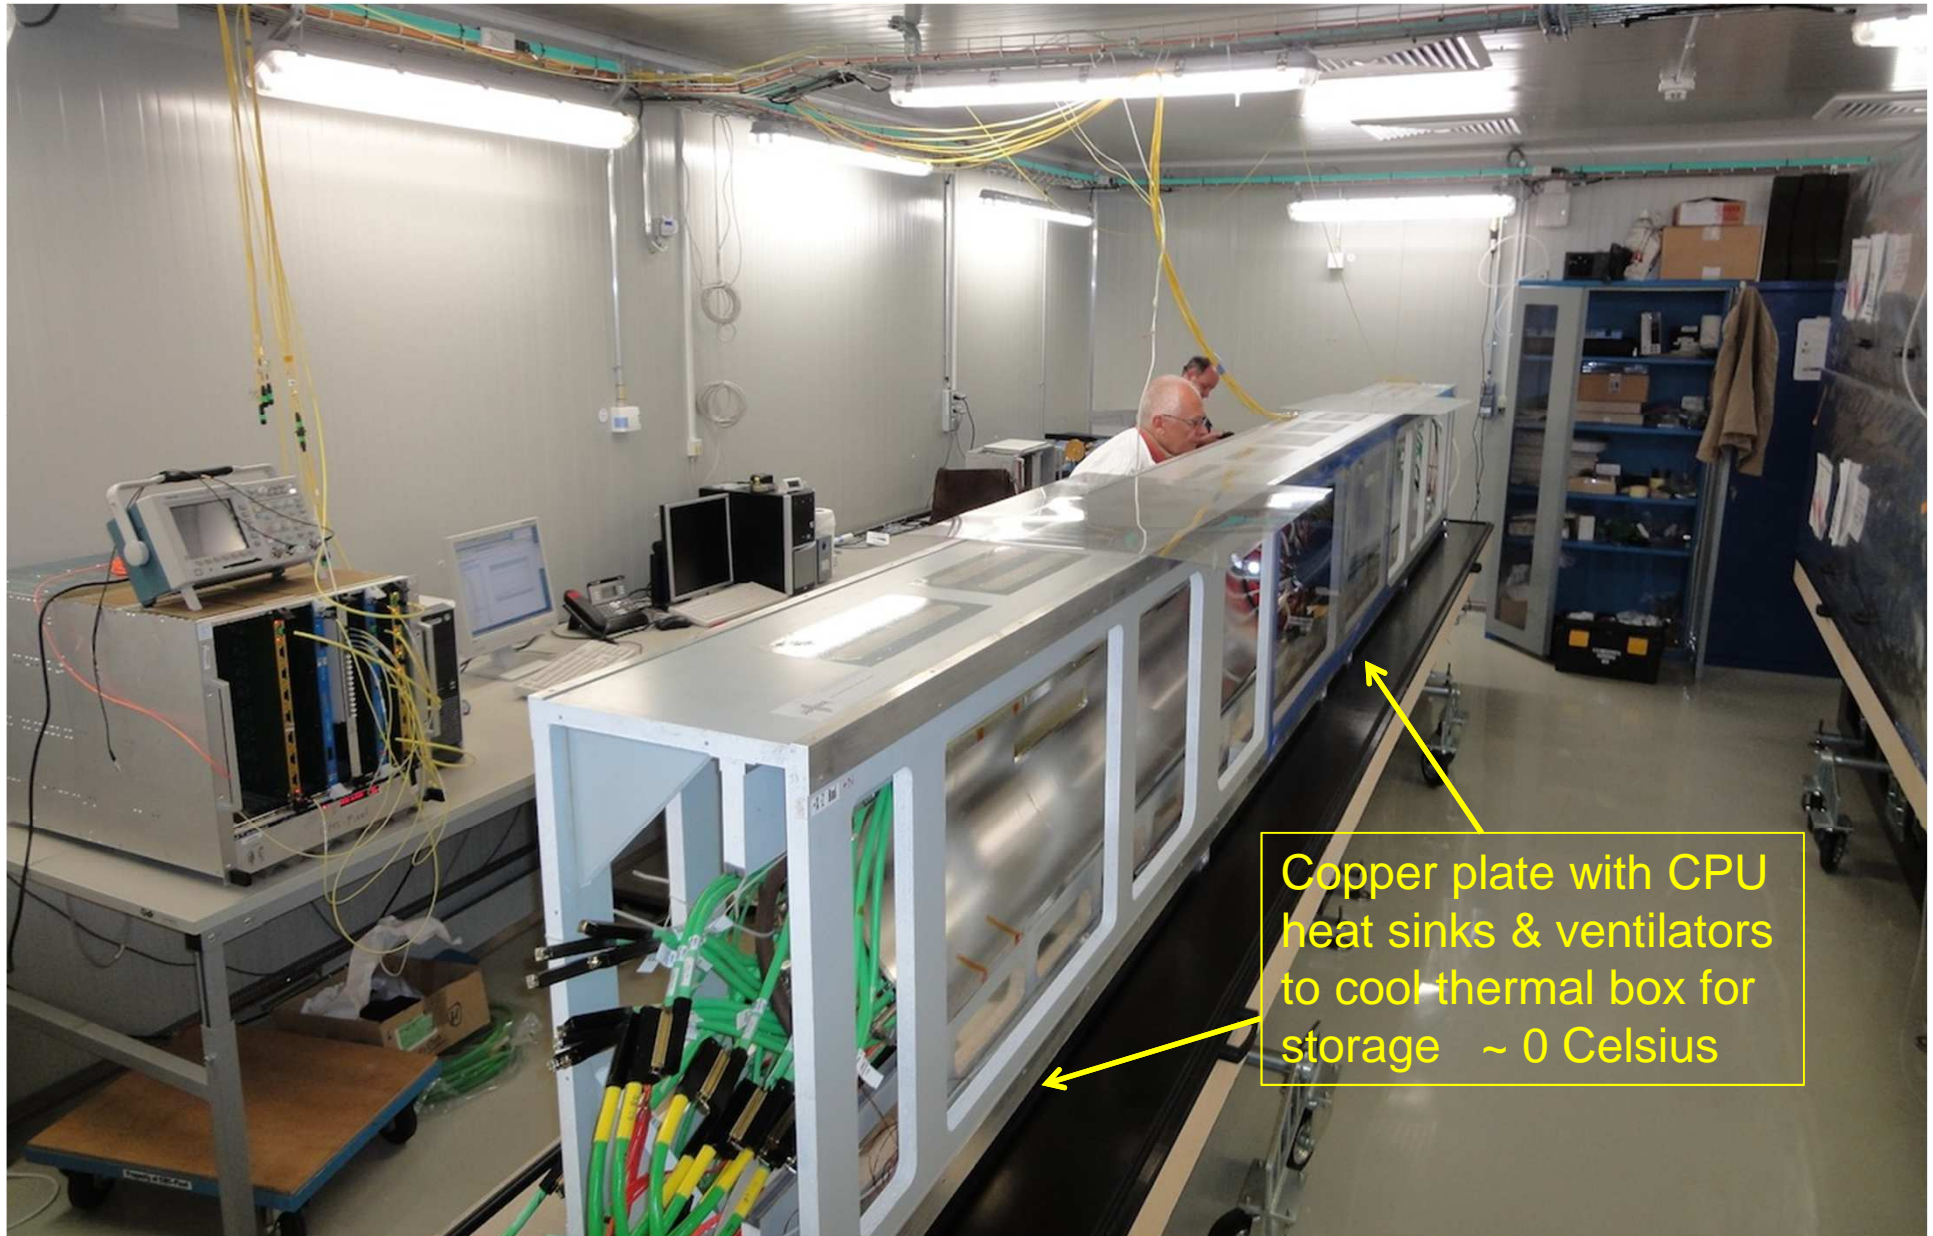
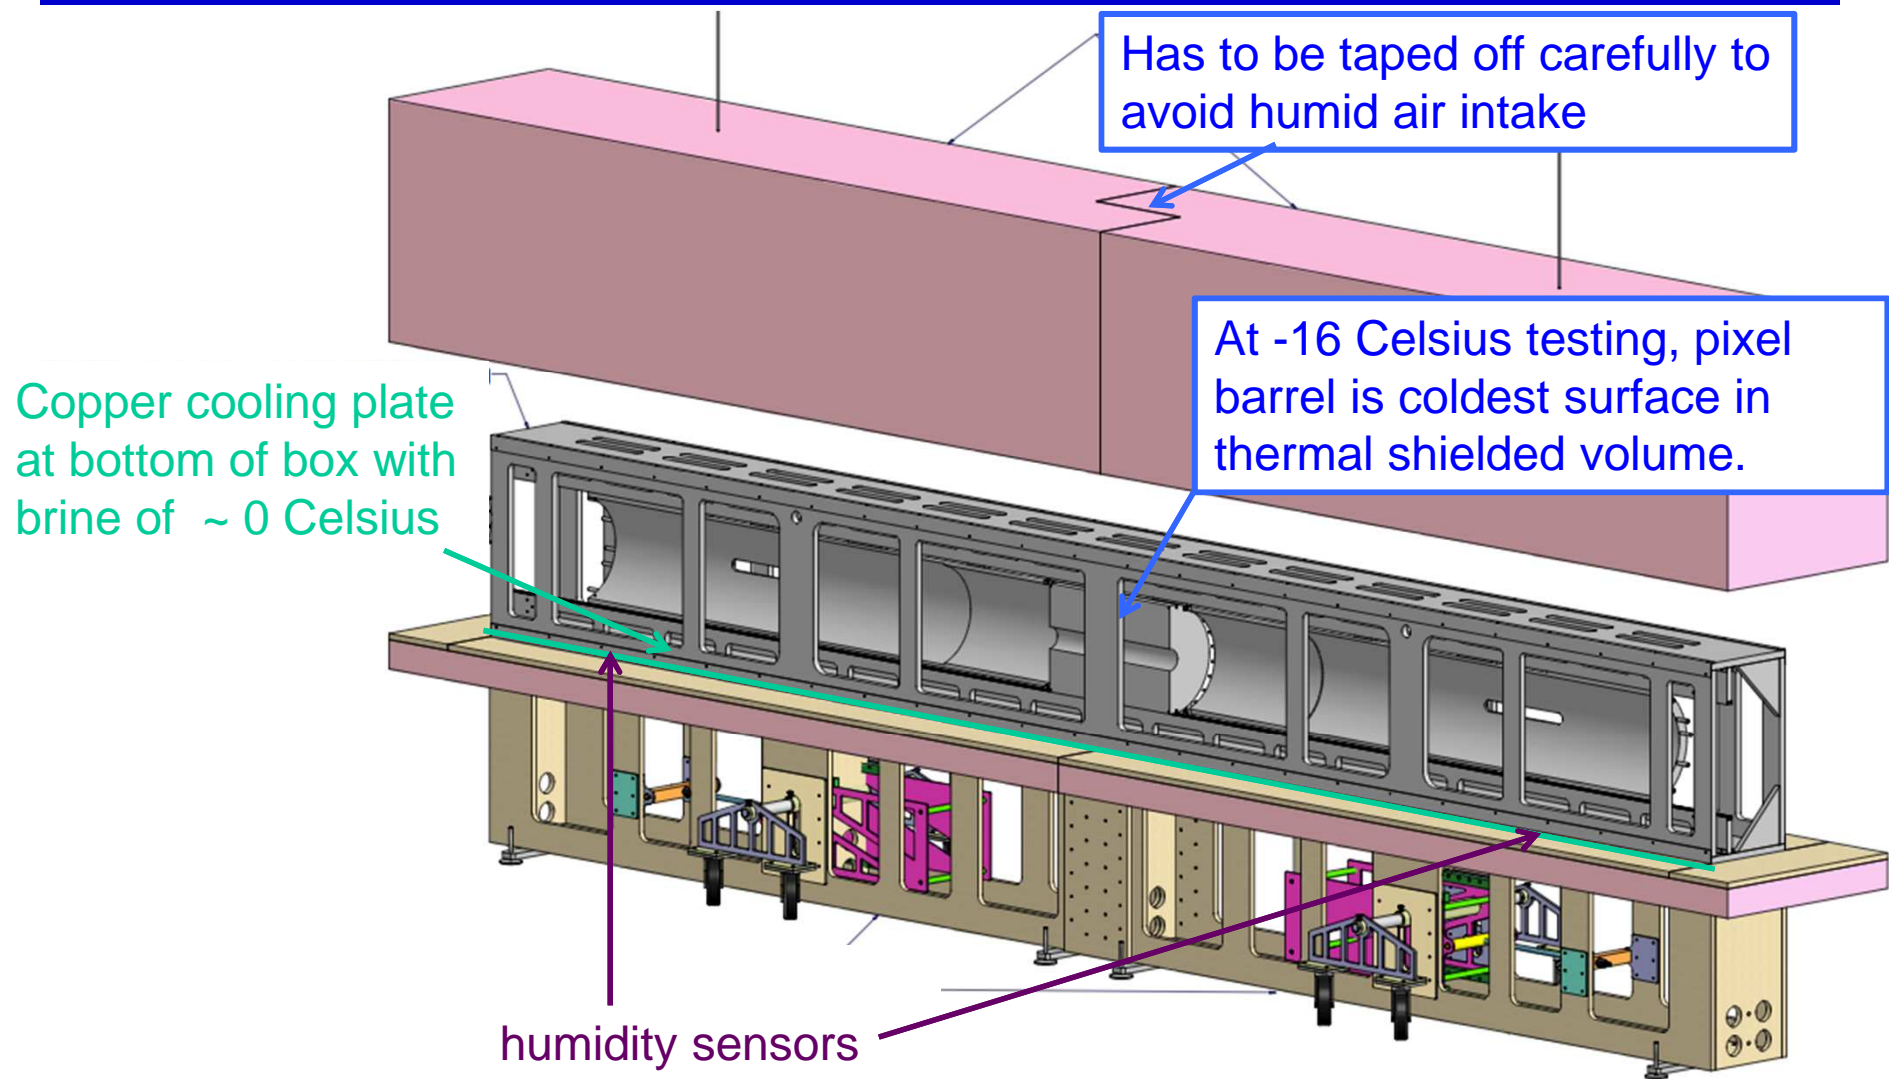
Cooling Tables of BPIX in P5 Pixel Lab

- thermal covers opened / closed many times 2013/14
- sealing in Nov/Dec 2013 tests probably left small leak at $z \sim 0$
- small plumes of humid air (\sim liters/min) leak inside volume

- local humidity cloud deposits micron thick ice film on **coldest surfaces** \rightarrow **pixel modules & cooling pipes** (-16°C)
- modules under power melt the ice, since HDI on top of sensor has poor thermal contact to cooling pipes.

- **sectors under test** with **power** gets **damaged** by electro-chemical migration with metalorganic-complexes from flux residues in very narrow, deep HDI cracks of early serial #'s.

- modules without power have inert ice film that will later sublime away again. (no power = no damage)
- humidity sensors at $z \sim \pm 200\text{cm}$ will not see anything !

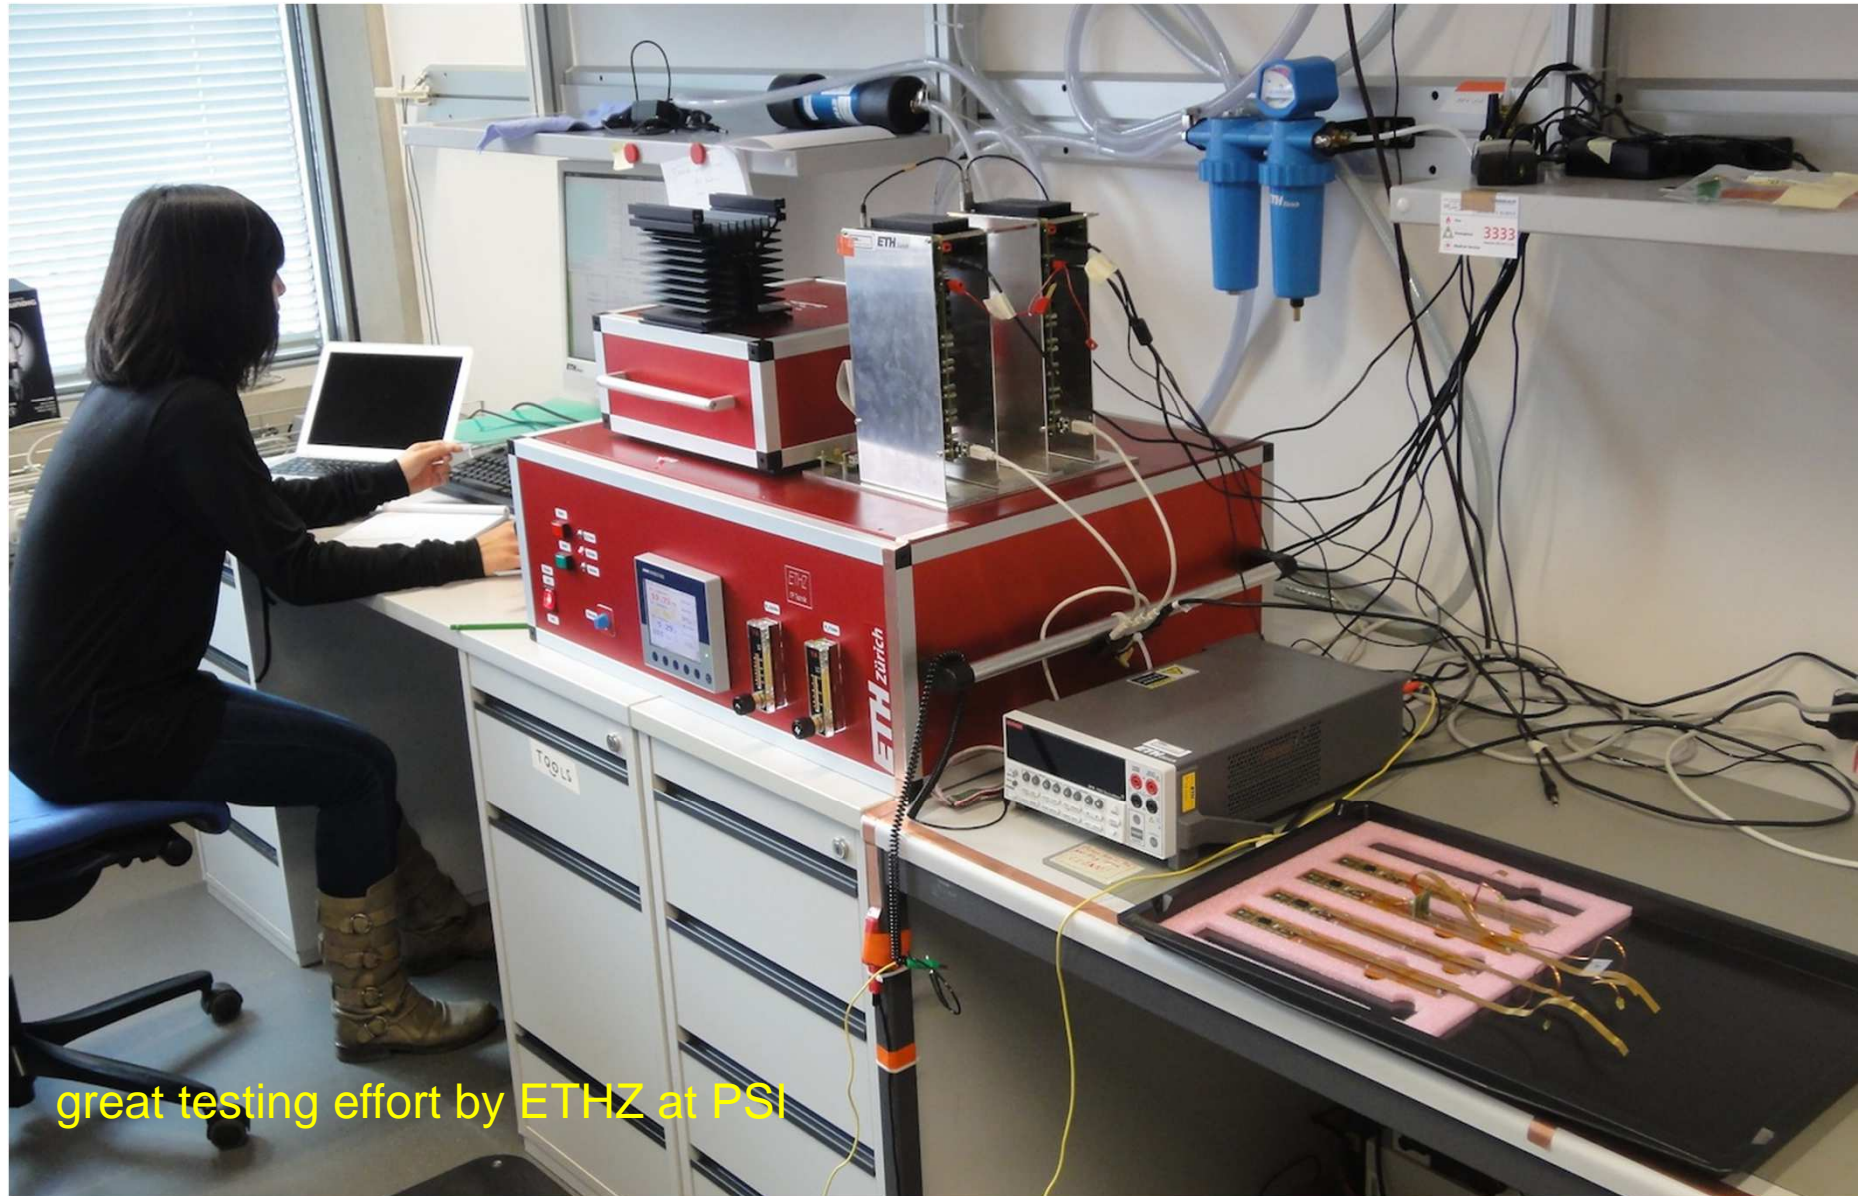
Testing & Qualification of BPIX Modules

great testing effort by ETHZ at PSI

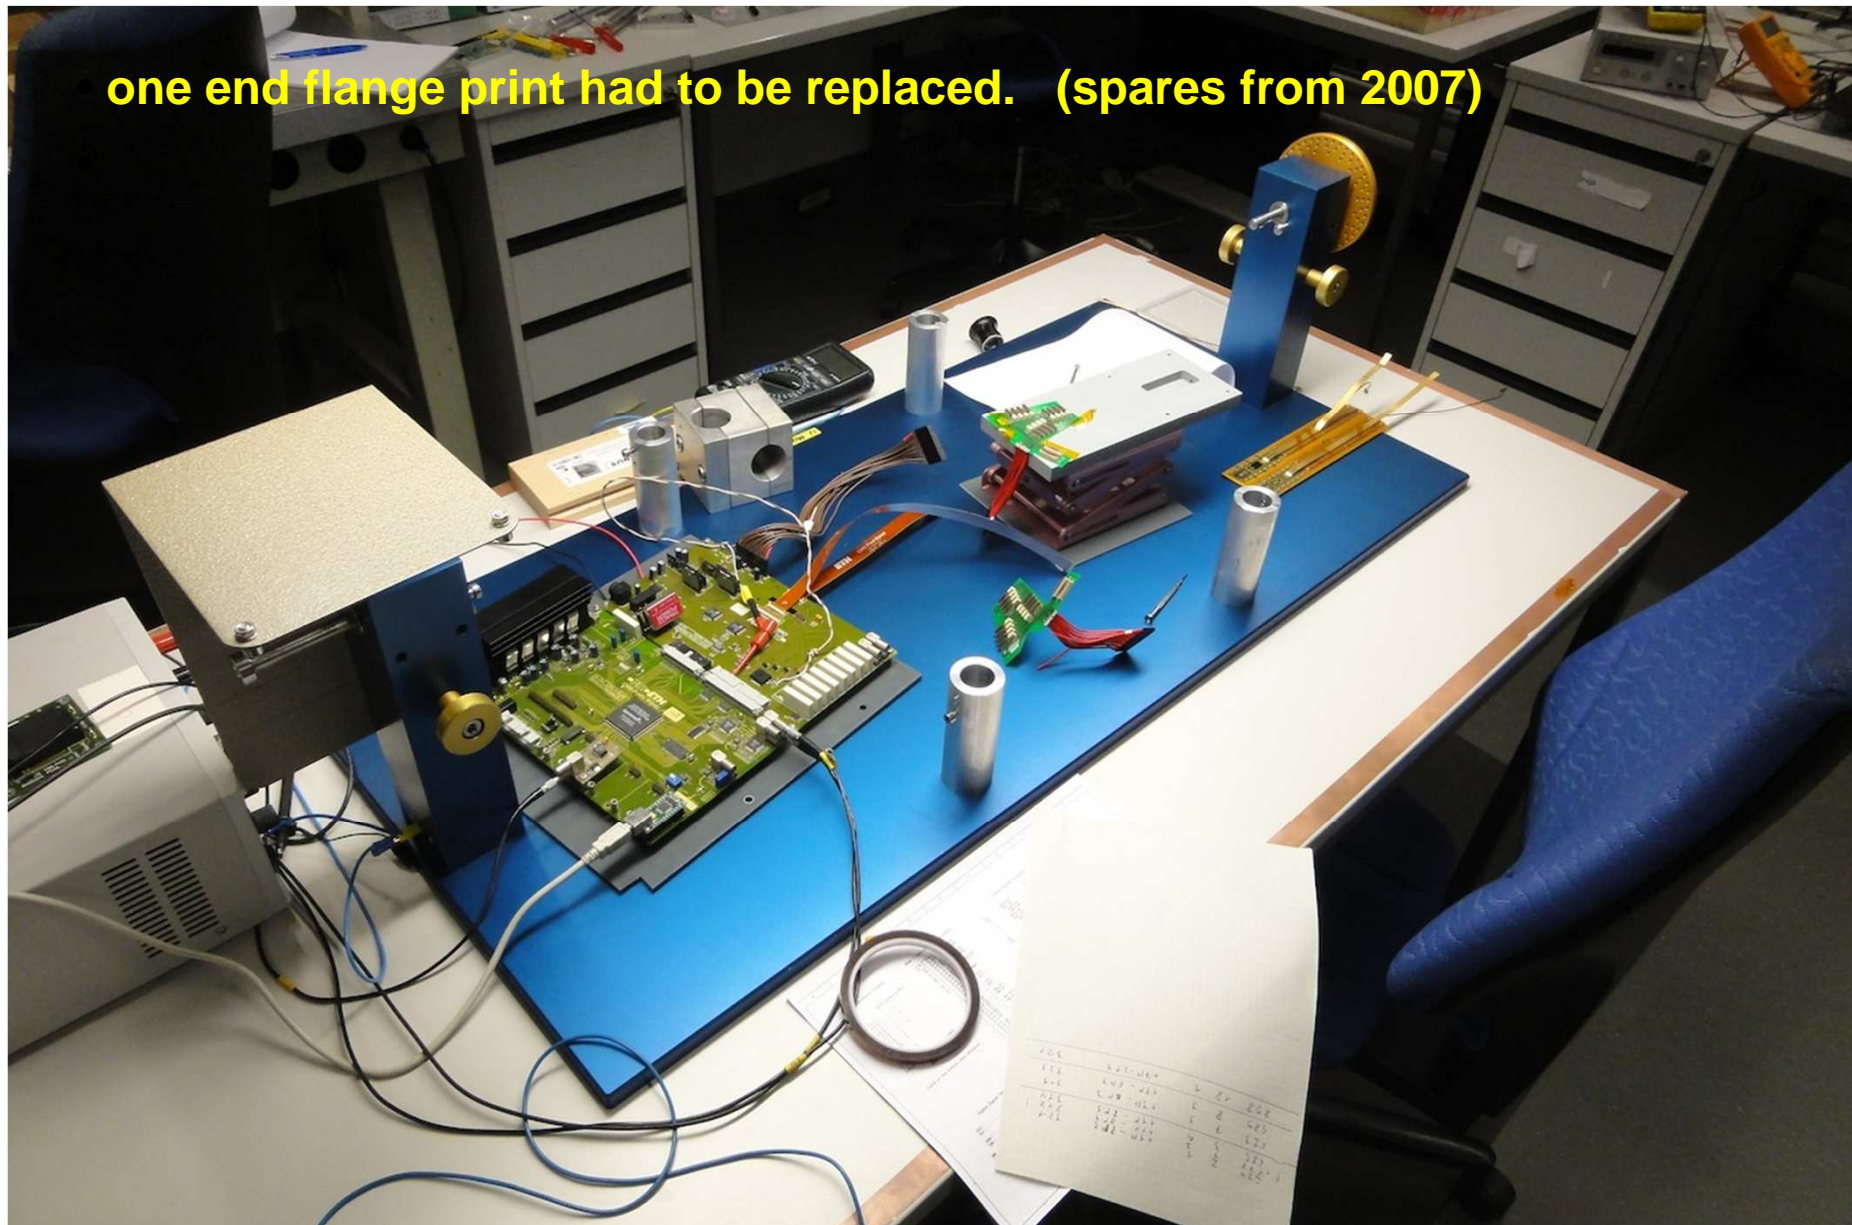
one end flange print had to be replaced. (spares from 2007)

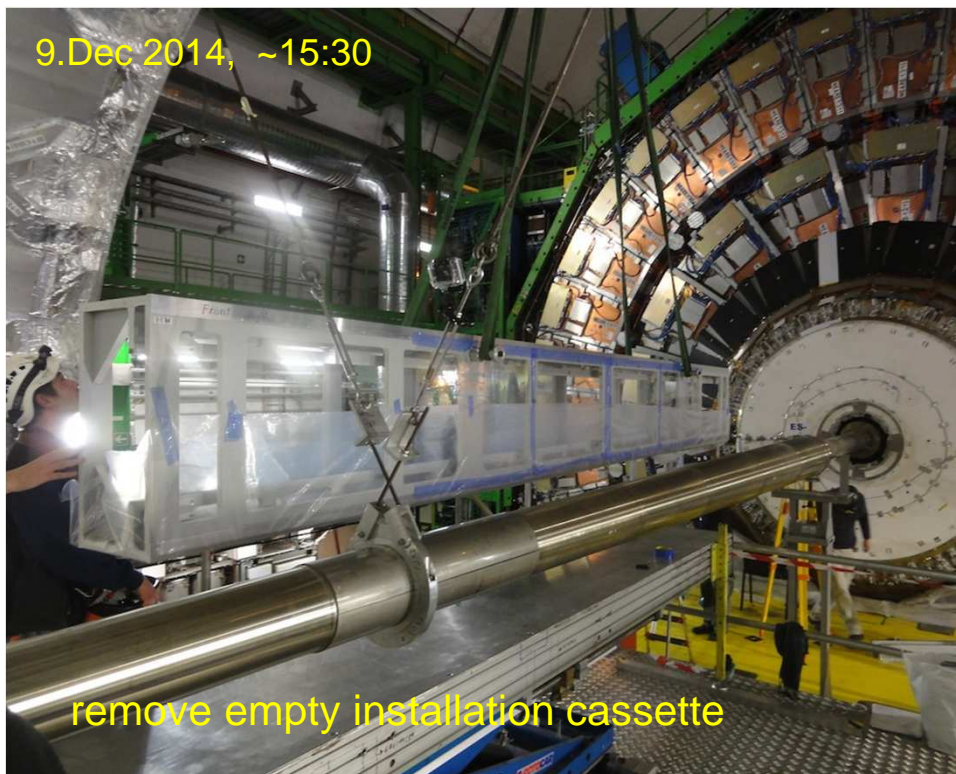
BPIX both sides installed

open issue:
thermal shield PP0
has no space for
cooling pipes
